Crossing ID: WC_0532

NSWA Sturgeon River Watercourse Assessment

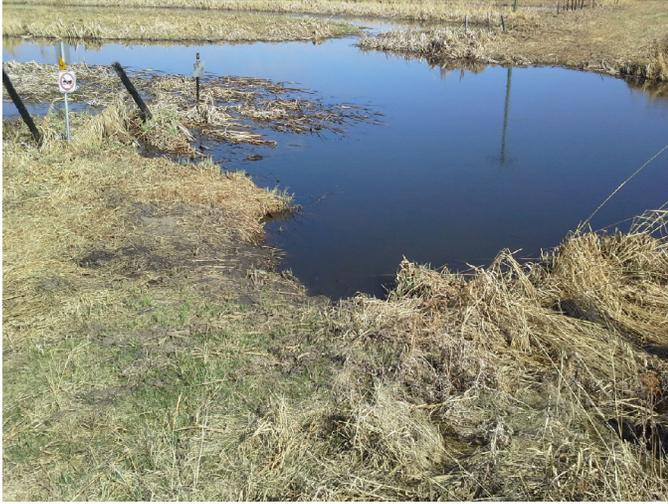
Photo No.: Photos-20180511-165850.jpg
Description: Snowmobile trail off water to ditch

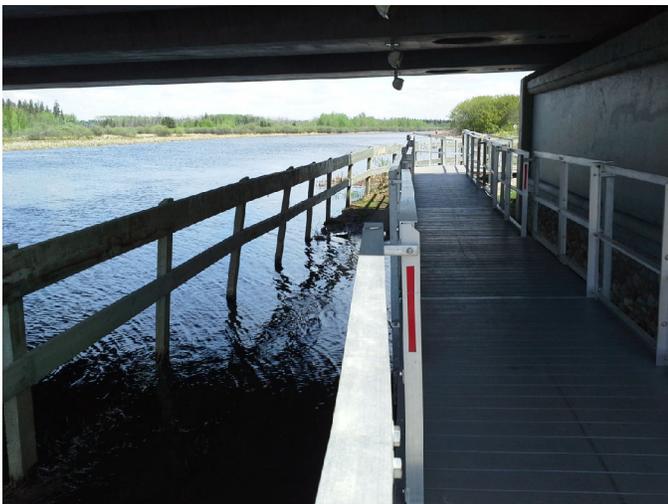
Comments: Walkway flooded, temporary lifted path created. Outlet of Big Lake

Photo No.: Photos-20180518-190443.jpg
Description: Flooding

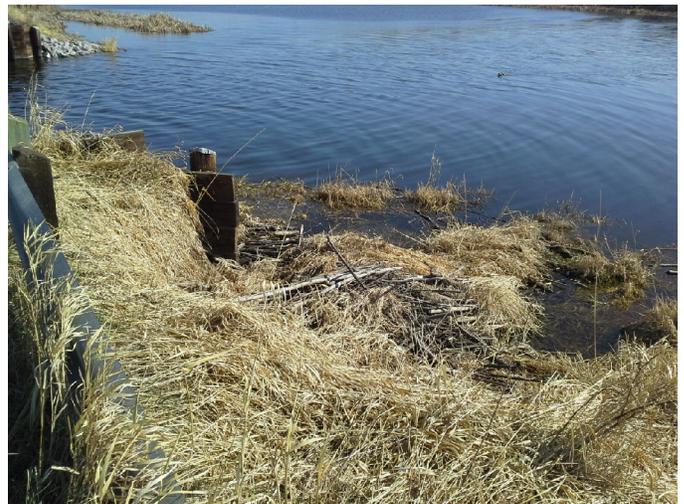
Comments: Riprap missing from southeast side of wingwall and slumping is noted. Site located on Isle Lake. Lots of lakeshore developments. Bridge sits low.

Photo No.: Photos-20180511-162040.jpg
Description: Erosion

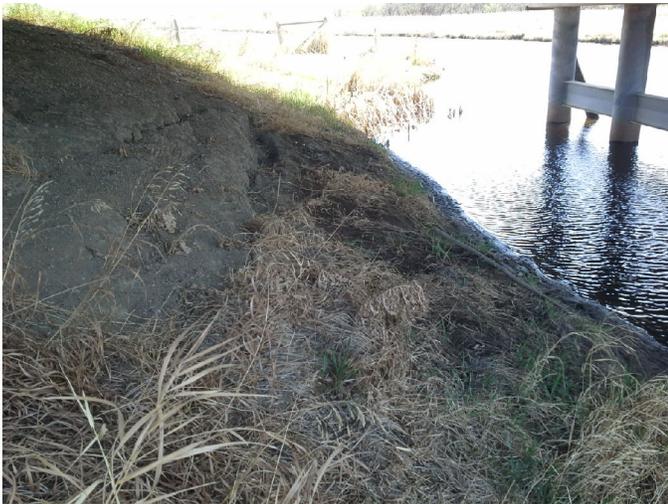
Comments: Fill slope erosion has potential to occur.

Photo No.: Photos-20180516-175804.jpg
Description: Erosion potential
