Crossing ID: WC_0854

NSWA Sturgeon River Watercourse Assessment

Inspection Date: May 15, 2018

Watercourse Name: Atim Creek

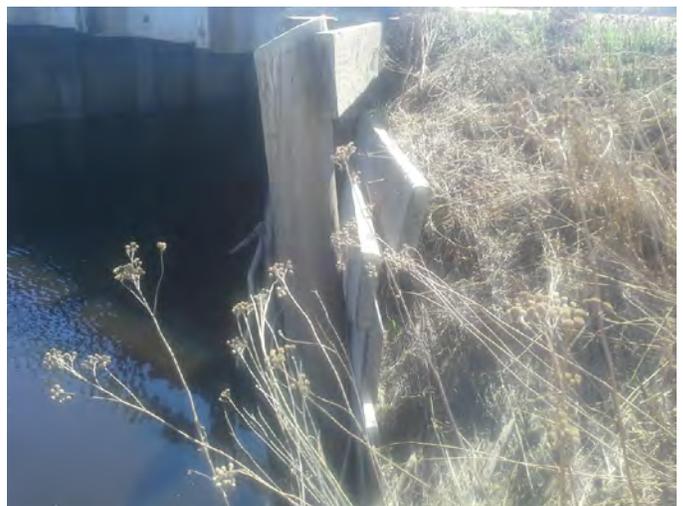
Wingwall Functioning?: No, damage to wingwall

Structural Problems: Damaged Guardrail, Other - large spaces between pavement deck slates, missing abutment piling, wingwall not secure

Photo No.: Photos-20180508-190608.jpg
Description: Wing Wall Damage

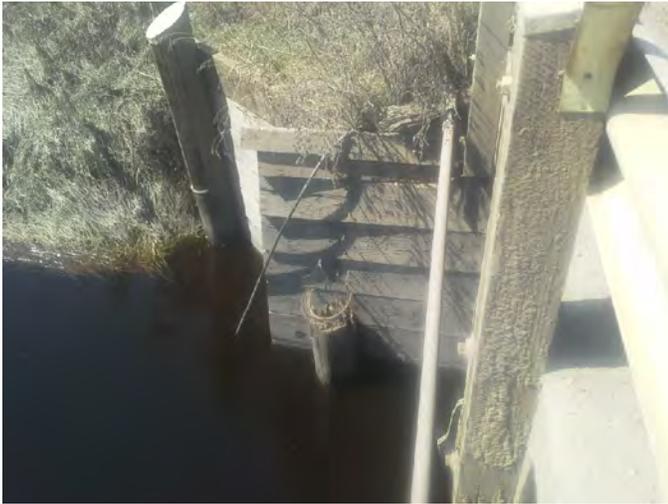
Abutment Functioning?: No, missing abutment

Photo No.: Photos-20180508-190647.jpg
Description: abutment Wall Damage

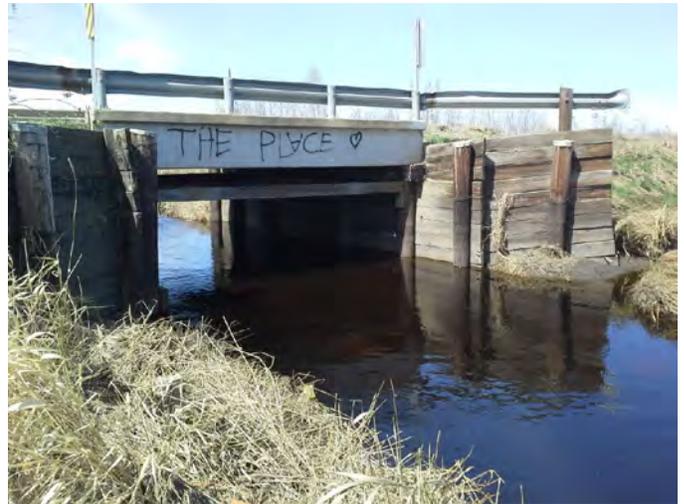
Photo No.: Photos-20180507-191928.jpg
Description: Outlet & Wingwall condition-materials falling

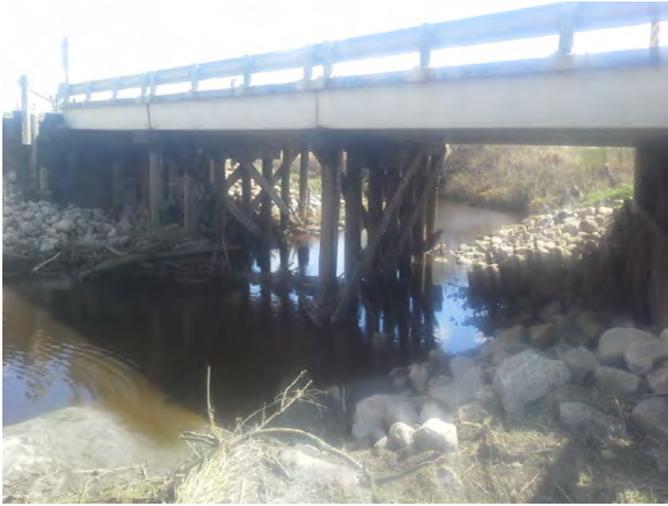
Comments: The abutments are looking like they need to be replaced. Looks like some work has been done but nothing that's meant to last for a long time. Since the abutments pilings are in the water, there are logs starting to collect creating blockages.

Photo No.: Photos-20180508-201729.jpg
Description: Inlet

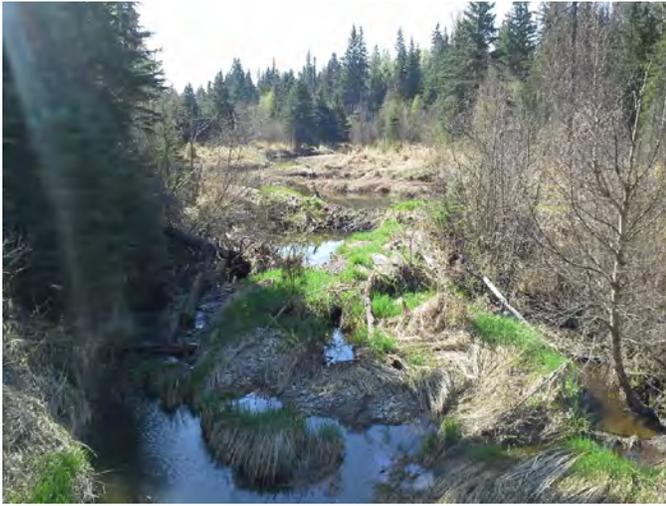
Comments: Materials eroding from under abutment wall. Small beaver dam noted approximately 25m upstream. This crossing is downstream of a gravel wash pit.

Photo No.: Photos-20180514-165644.jpg
Description: Upstream

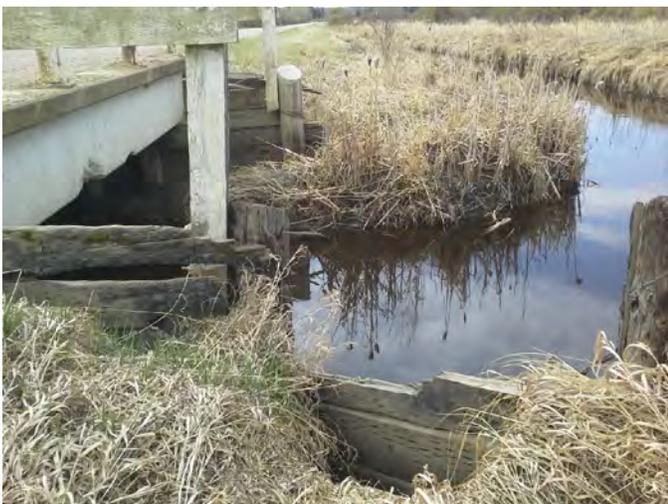
Photo No.: Photos-20180509-173431.jpg
Description: Wing wall damage and lack there of wingwall as well rotting on east side top

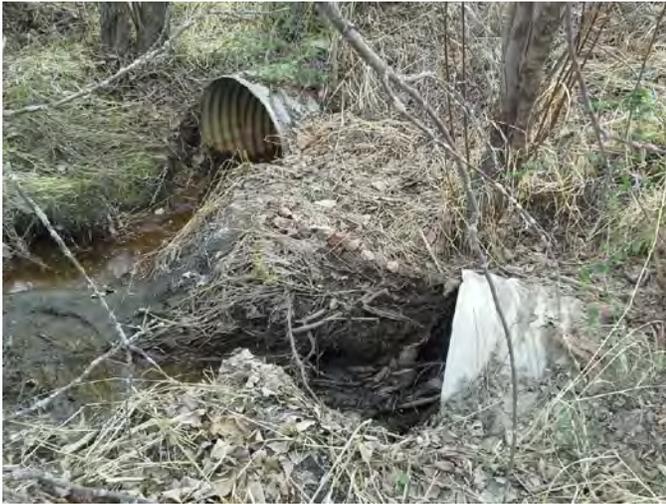
Comments: Inlets are about 30 meters apart but the outlets are within a meter of each other. Erosion is caused by slumping around outlets. Inlet gap noted at the east inlet. There is some blockage on the west inlet with large rocks. Outlet east has an accumulation of organic debris causing some blockage.

Photo No.: Photos-20180509-163349.jpg
Description: Outlets
