Beavers, water, and a way forward

Alberta WPACs World Water Day
Glynnis Hood, University of Alberta, Augustana
March 22, 2023

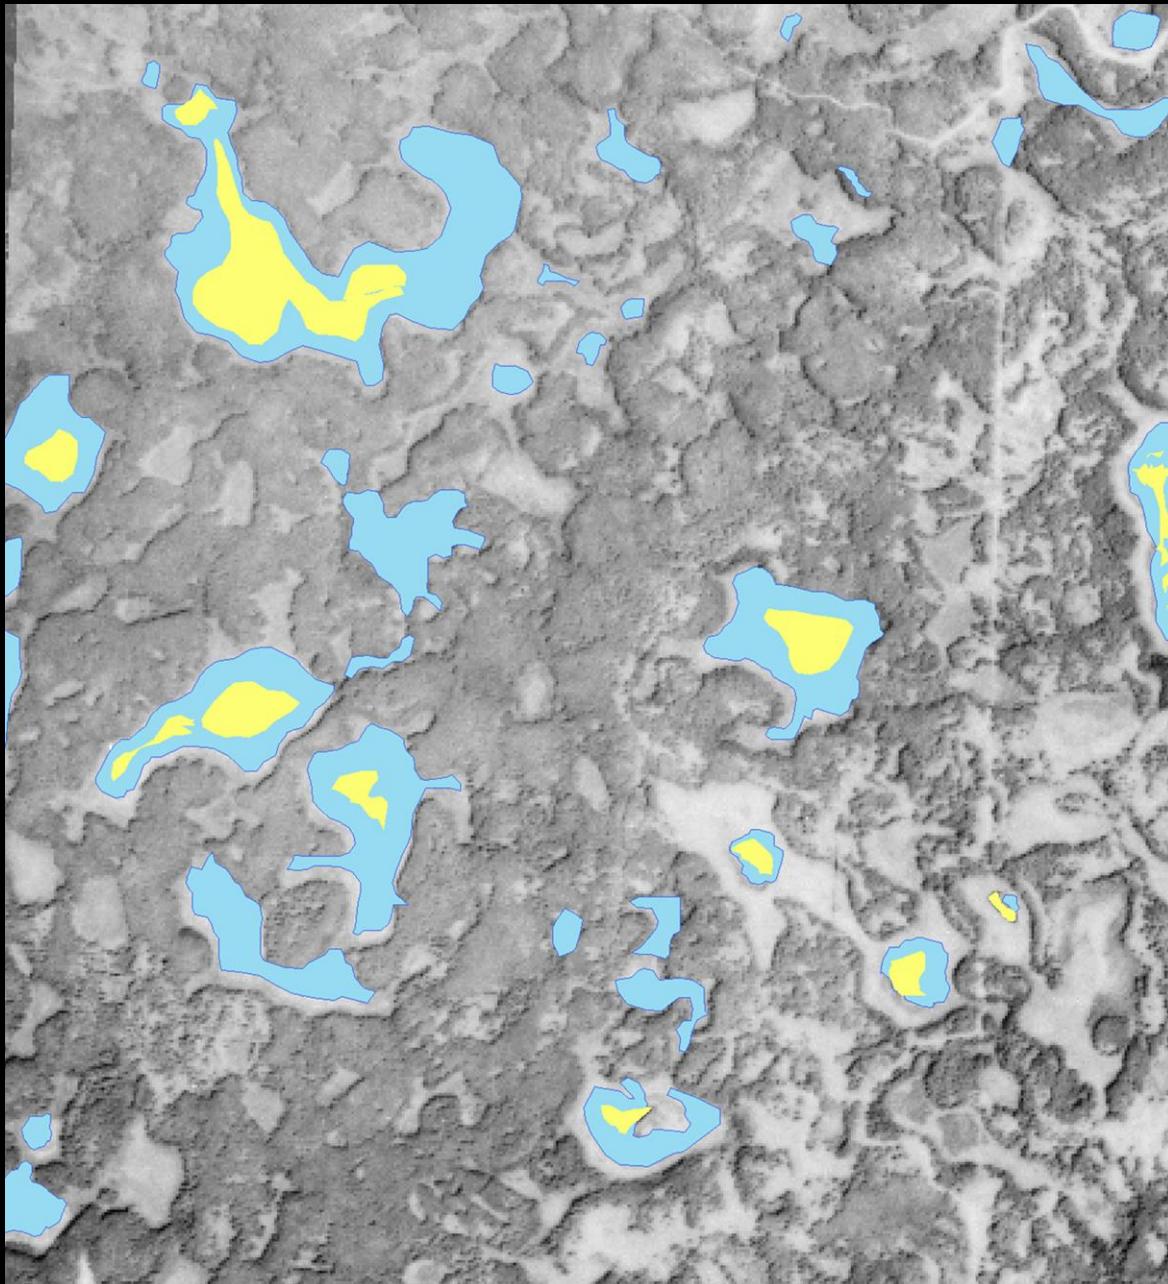
➤ 1950

- 47% more precipitation than 2002
- no beaver
- less open water

➤ 2002

- driest year on record
- beaver well-established
- 61% more open water than 1950

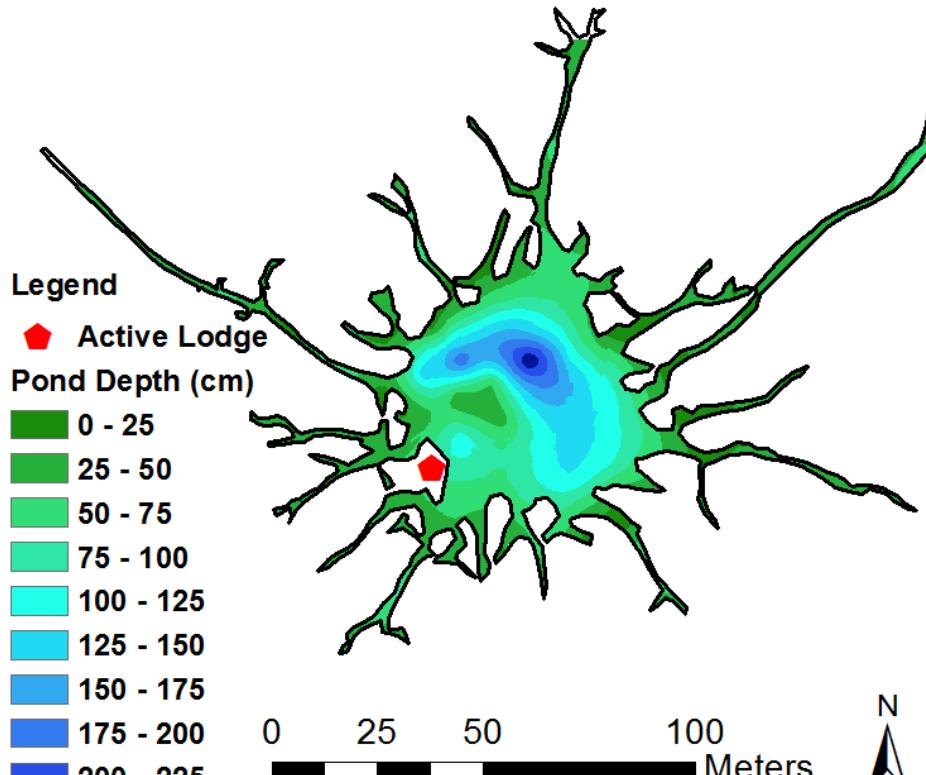
Pond 26 Bathymetry

Hood and Larson. 2015. *Freshwater Biol.*

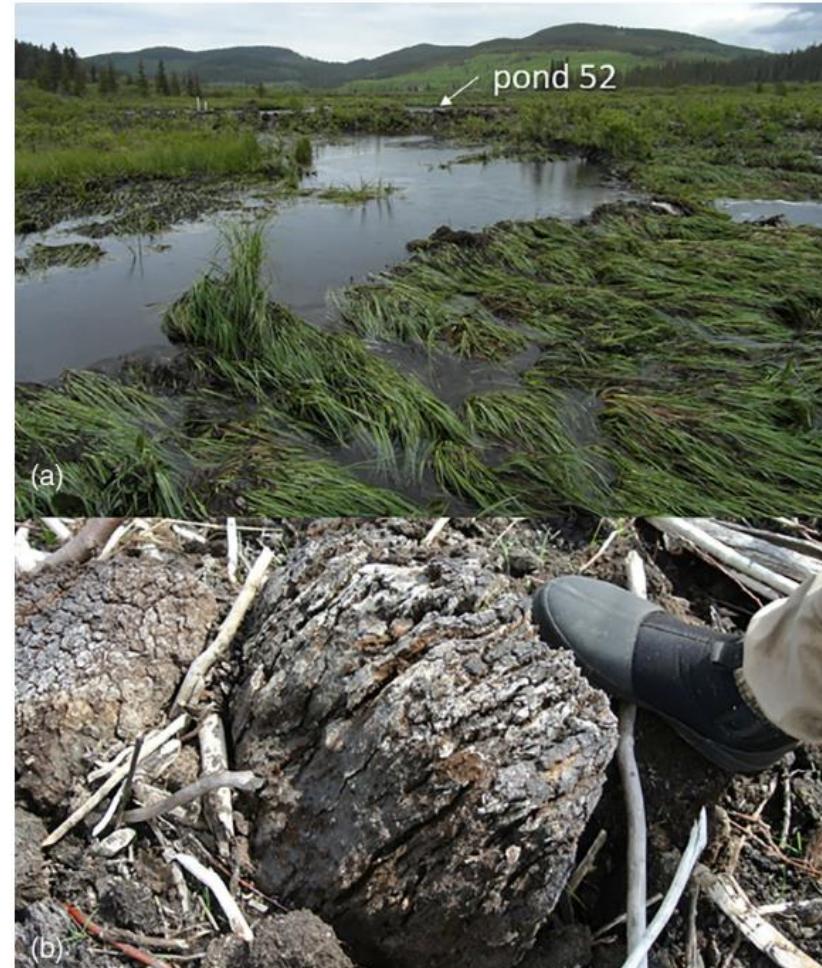
FIGURE 6 Photographs of:

- (a) Pond 52 after the flood event (June 30, 2013) showing flattened vegetation indicating outburst flood from pond 53 water flowed overtop of it, leaving the dam reasonably intact and the pond storing water; and
(b) blocks of peat sheared from just below the dam breach at pond 53 found approximately 50 m downstream

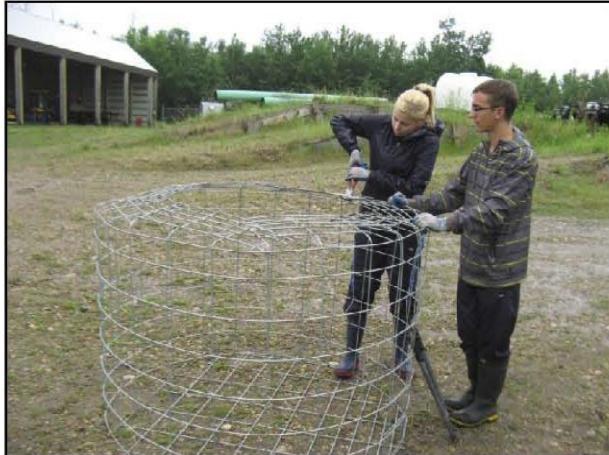
1. Building the cage

Building a pond leveller at a bridge site

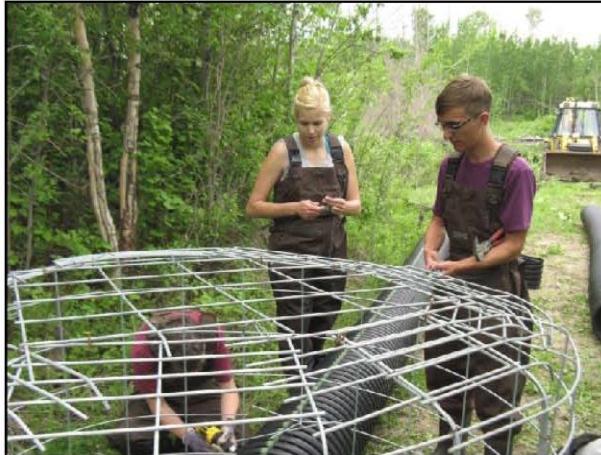
2. Attaching pipe to cage

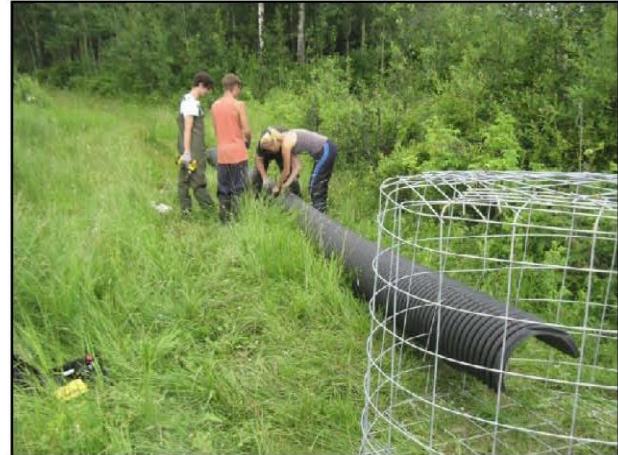
3. Joining the pipes

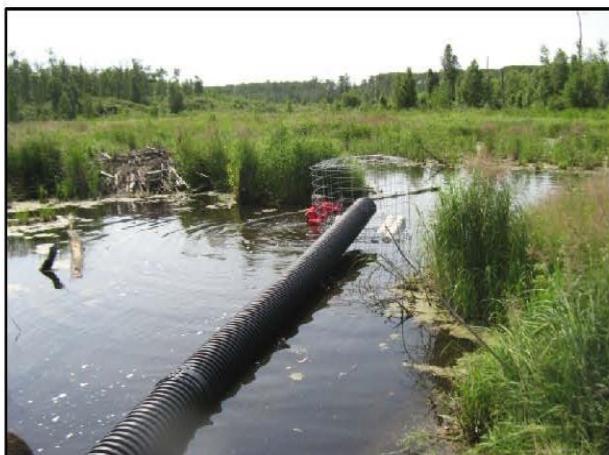
4. Floating the cage

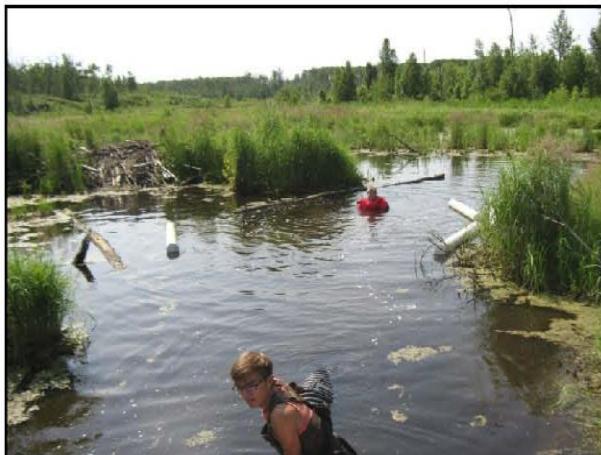
5. Dropping cage and pipe

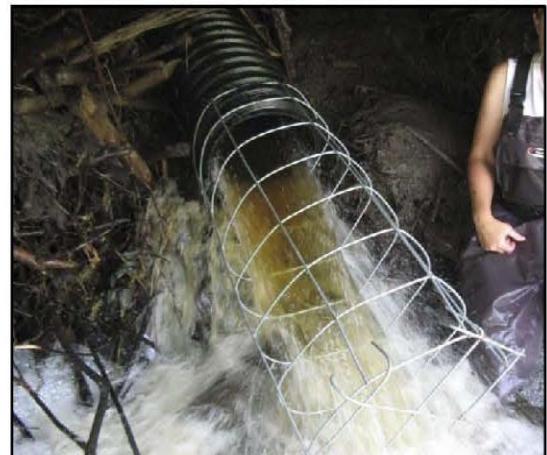
6. Protecting the end
