Assessing Riparian Intactness in the North Saskatchewan River Watershed using a GIS-based Approach

Watershed Wednesday Series April 28, 2021

Shari Clare, PhD, PBiol

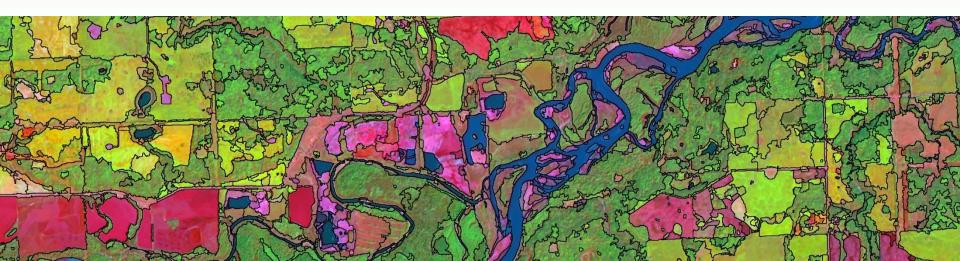
Quantifying Riparian Intactness Using GIS

- Intactness is calculated using land cover data
- A land cover is typically created using satellite imagery in combination with other data (e.g., terrain information)
- Vegetation and other surfaces (e.g., bare ground, buildings) are classified using machine learning techniques

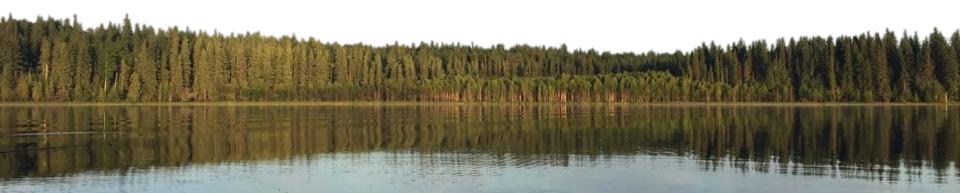
Intactness Metrics

- Intactness within each RMA is assessed using land cover data by quantifying and combining three metrics:
 - 1. Percent cover of all natural vegetation cover classes
 - 2. Percent cover of land cover classes that are composed of woody vegetation (e.g., trees and shrubs)
 - 3. Percent cover of all land cover classes associated with human activity (e.g., agriculture, urban, roads, etc.)

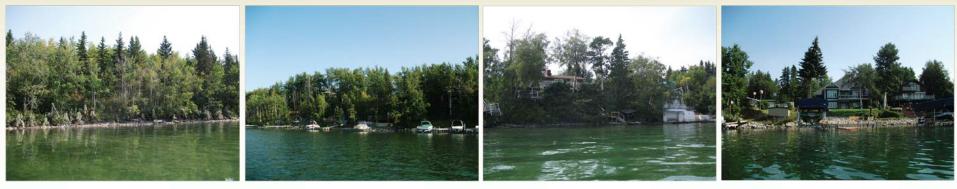
Intactness Categories & Scores

High (75-100)

Moderate (50-75) **Low** (25-50)

Very Low (0-25)

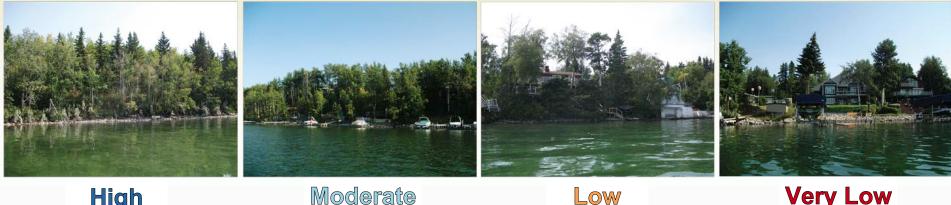
Intactness Categories & Scores

High (75-100) Moderate (50-75)

(25-50)

Very Low (0-25)
