Cynthia's Solar Aquatics System

**Prepared by
Brazeau County**

Welcome to Cynthia's Solar Aquatics Waste Water Treatment Facility

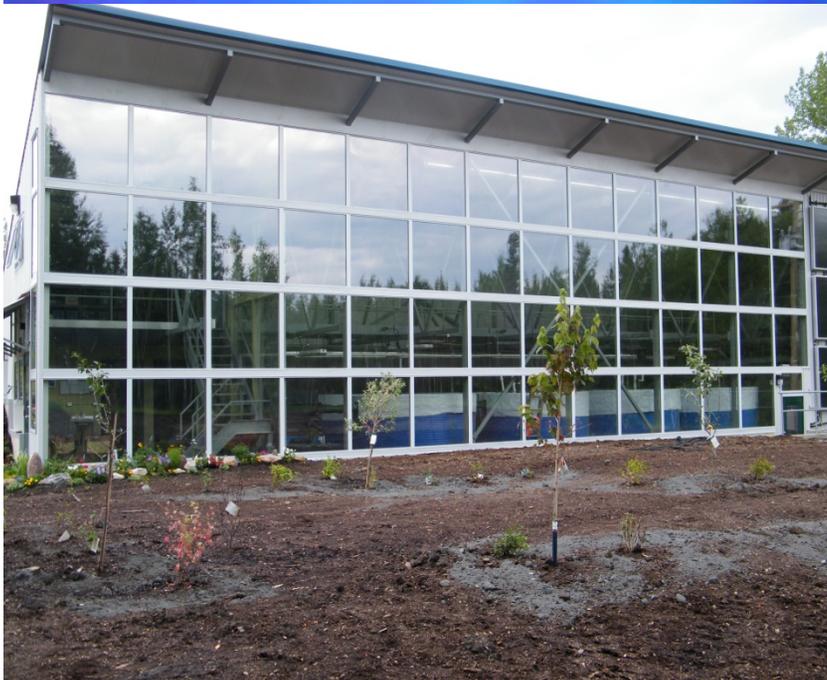
Sunlight entering building
assists in heating.

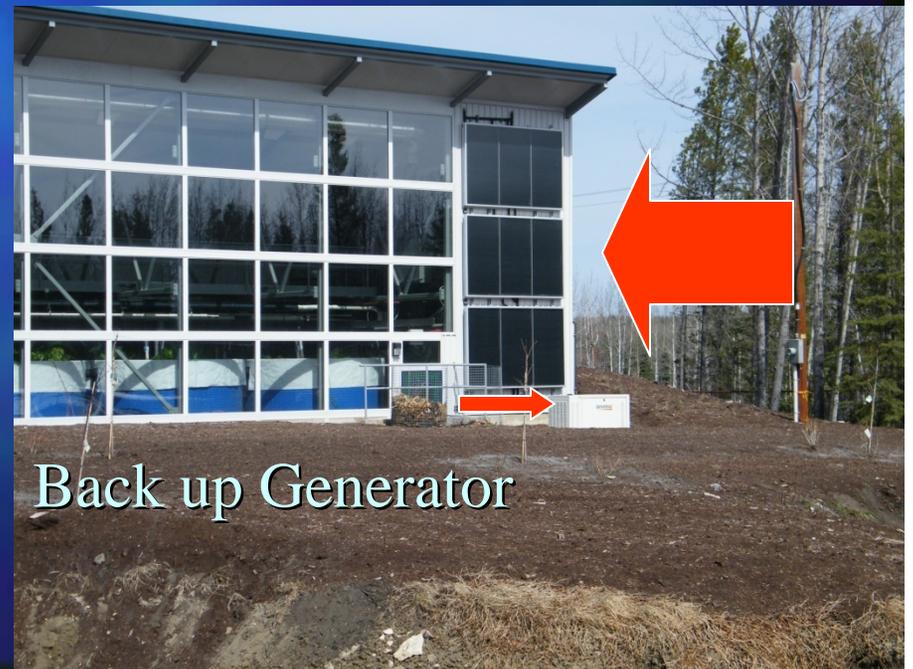
Three Solar heat collectors can be
found on the corner of the facility

- Climate Related :
- HVAC system needed better design. We've had to add a second boiler and an in line heat source in the air exchange unit to react more quickly to dropping temps. when the sun goes down.
- Large temp. fluctuations caused severe moisture buildup from condensation and required the installation of two large de-humidifiers.
- The solar heat collectors lasted one winter then the piping burst.

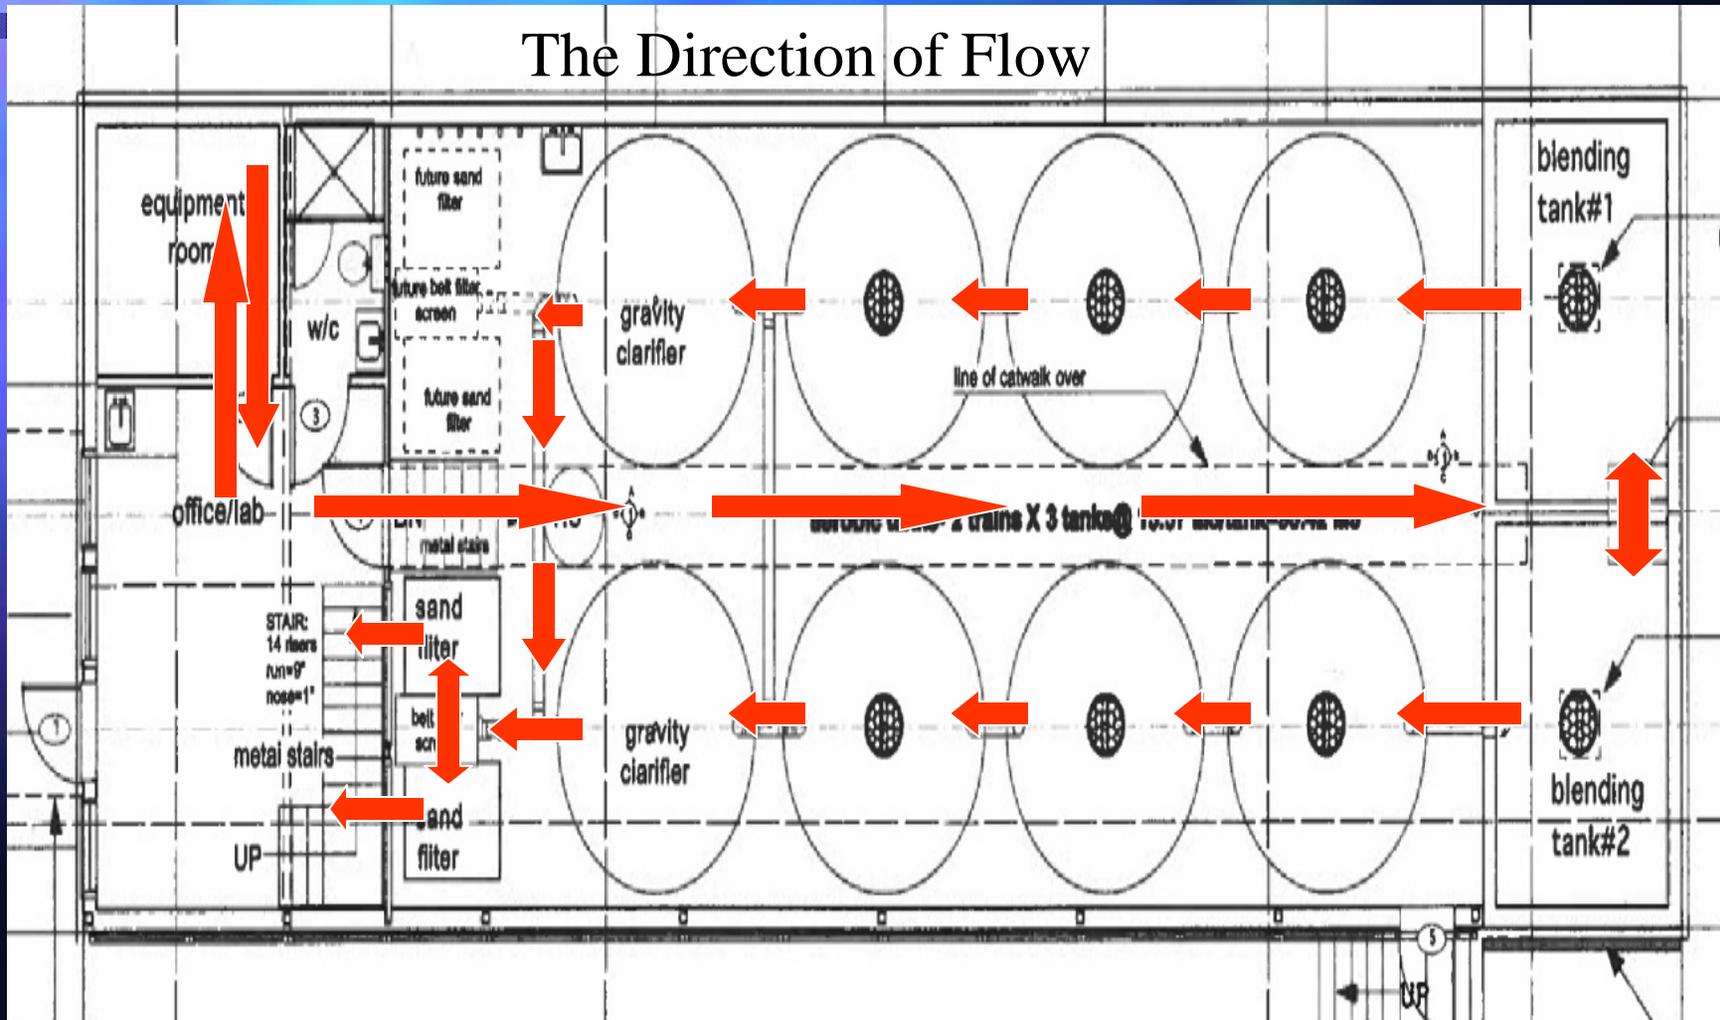
The Ground Plan

The Direction of Flow

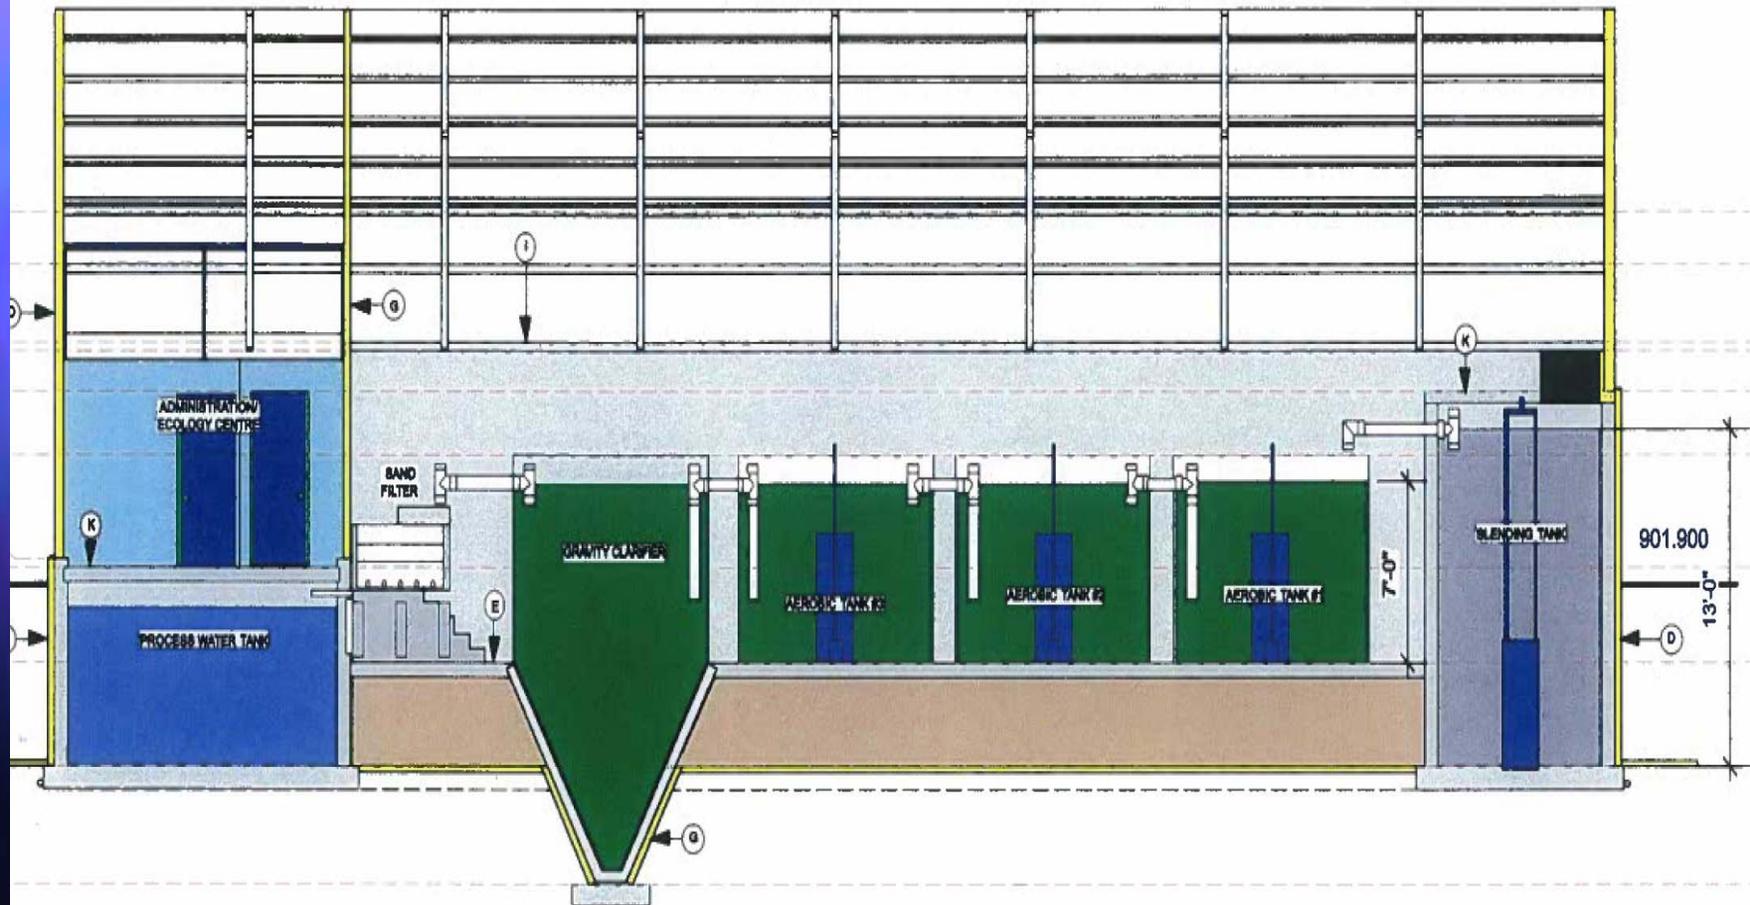
Side Elevation of Facility including tanks

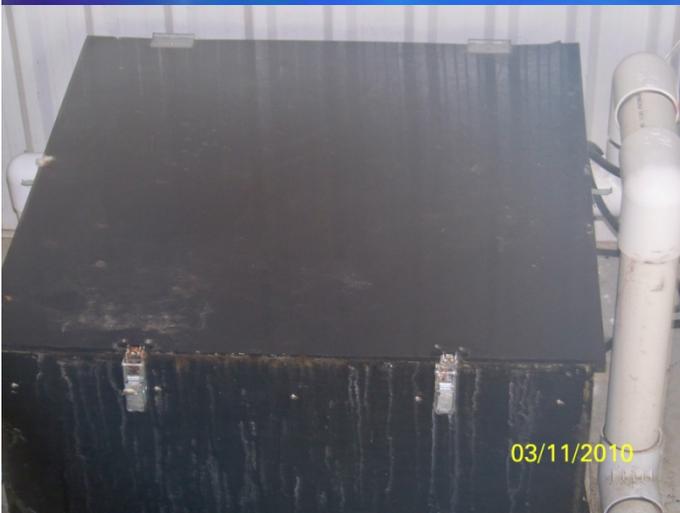
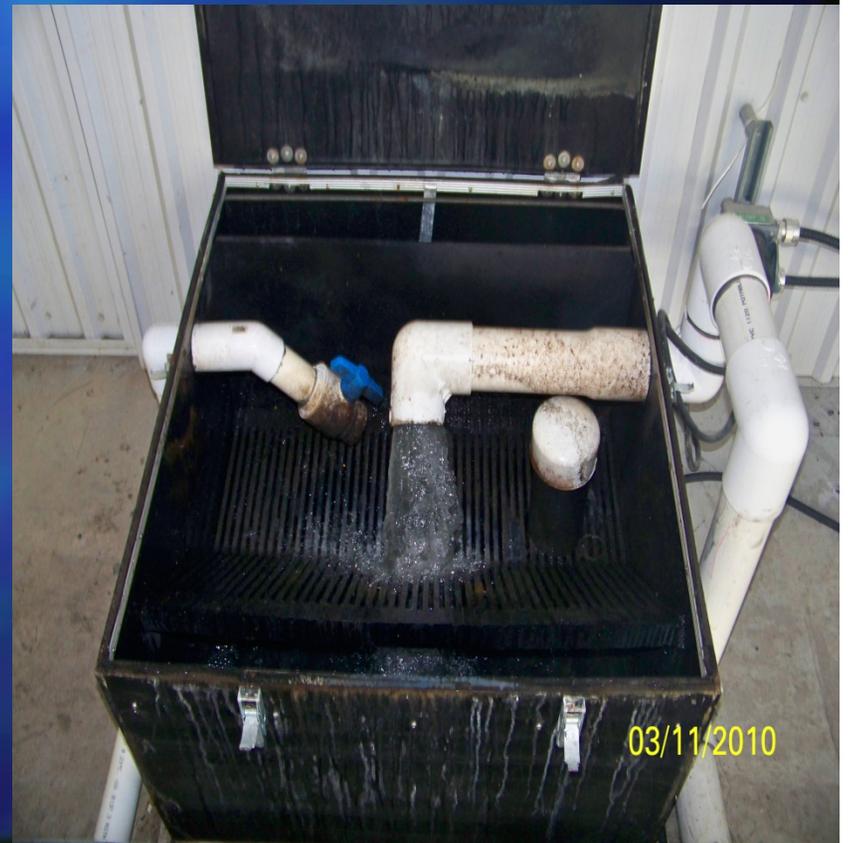
Catwalk: Far end is Splitter Box

Splitter Box open; plant bringing in a "load"

Splitter Box

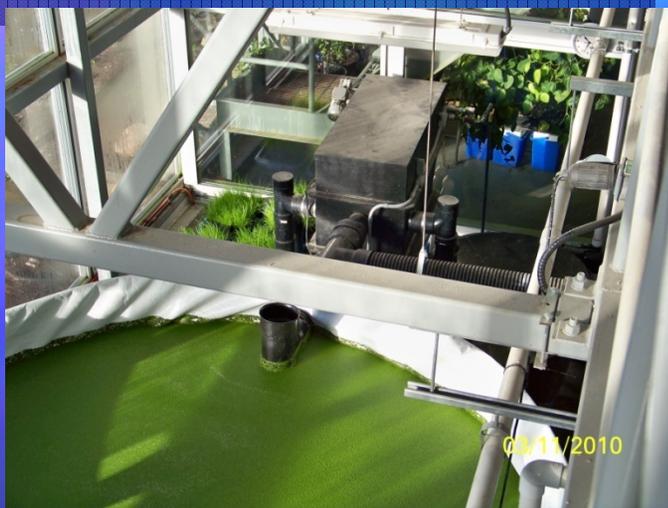
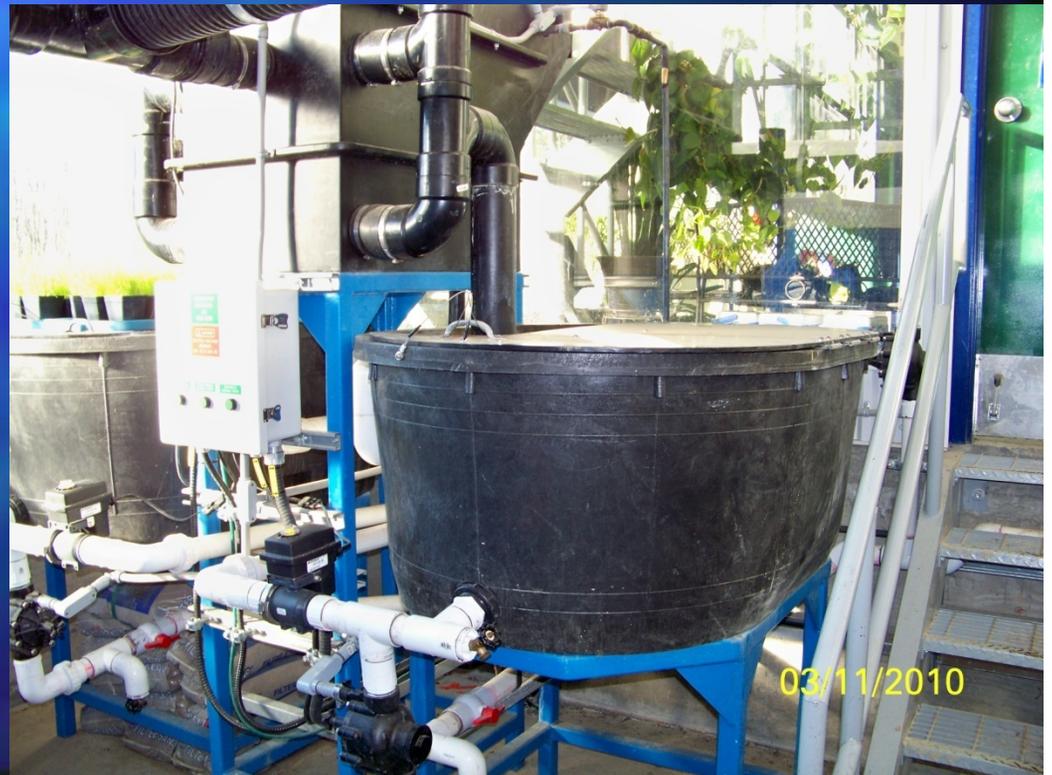
Micro Screen and Sand Filters

- Operations:
- The original venturi type aeration system was non functional and replaced with a conventional system.
- Some trial and error has been required to find the right plants and manage the damaging bugs.
- A larger sand filter will be required to handle the larger than expected volumes due to high population numbers in the warmer months from oilfield workers camping and also infiltration within the collection system.

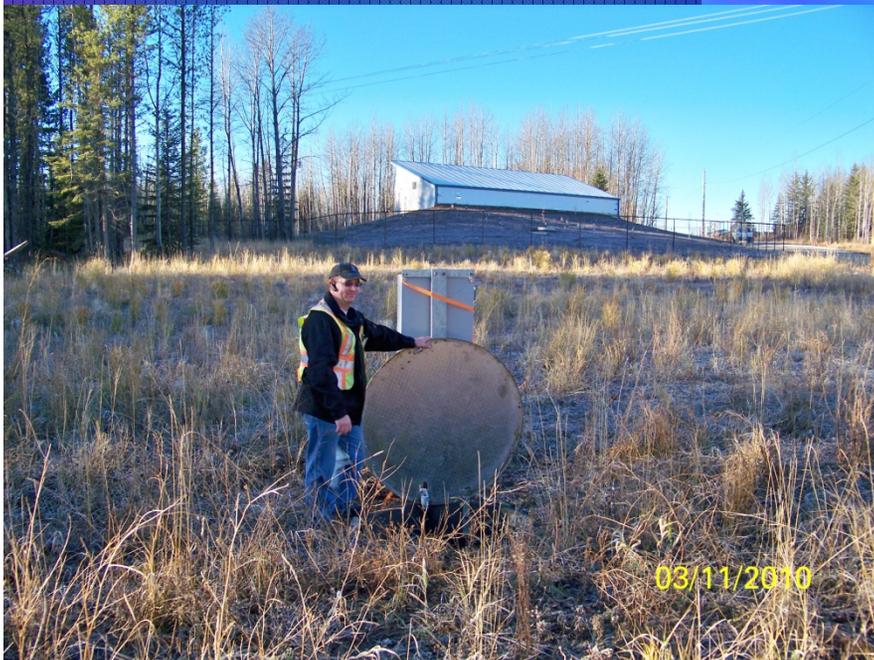
Surge Tank Lid opened:
SAS plant in background

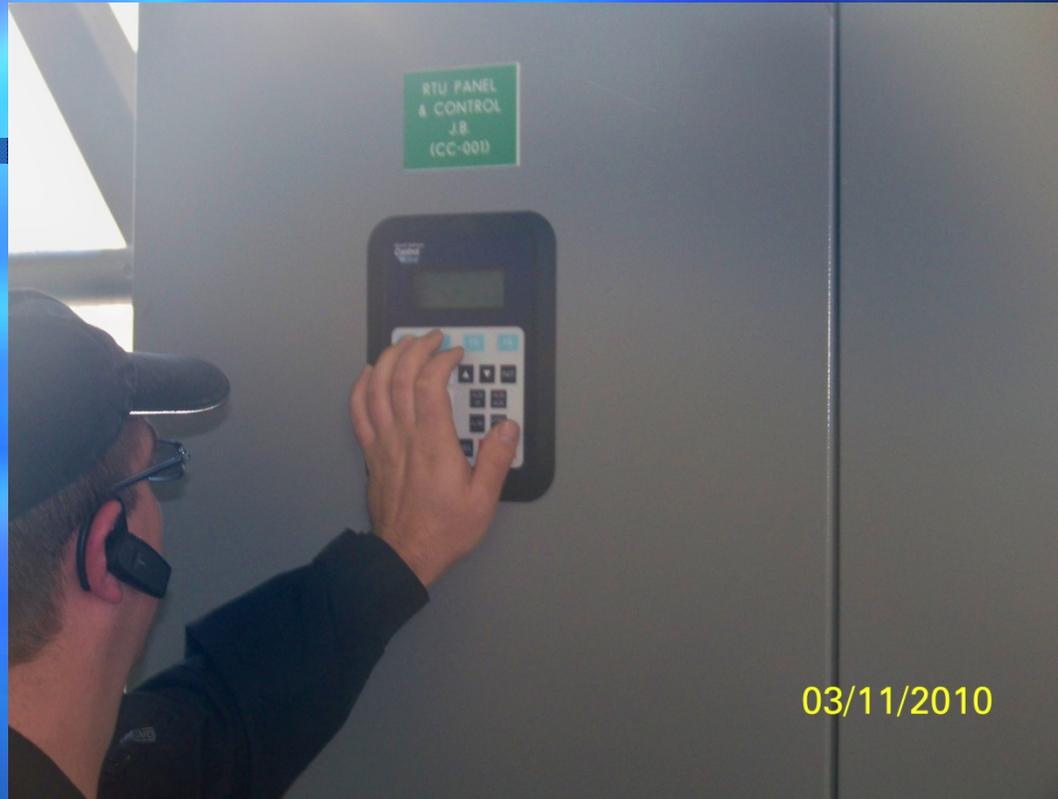
RTU unit controls Aeration, back wash, incoming effluent, and many other functions

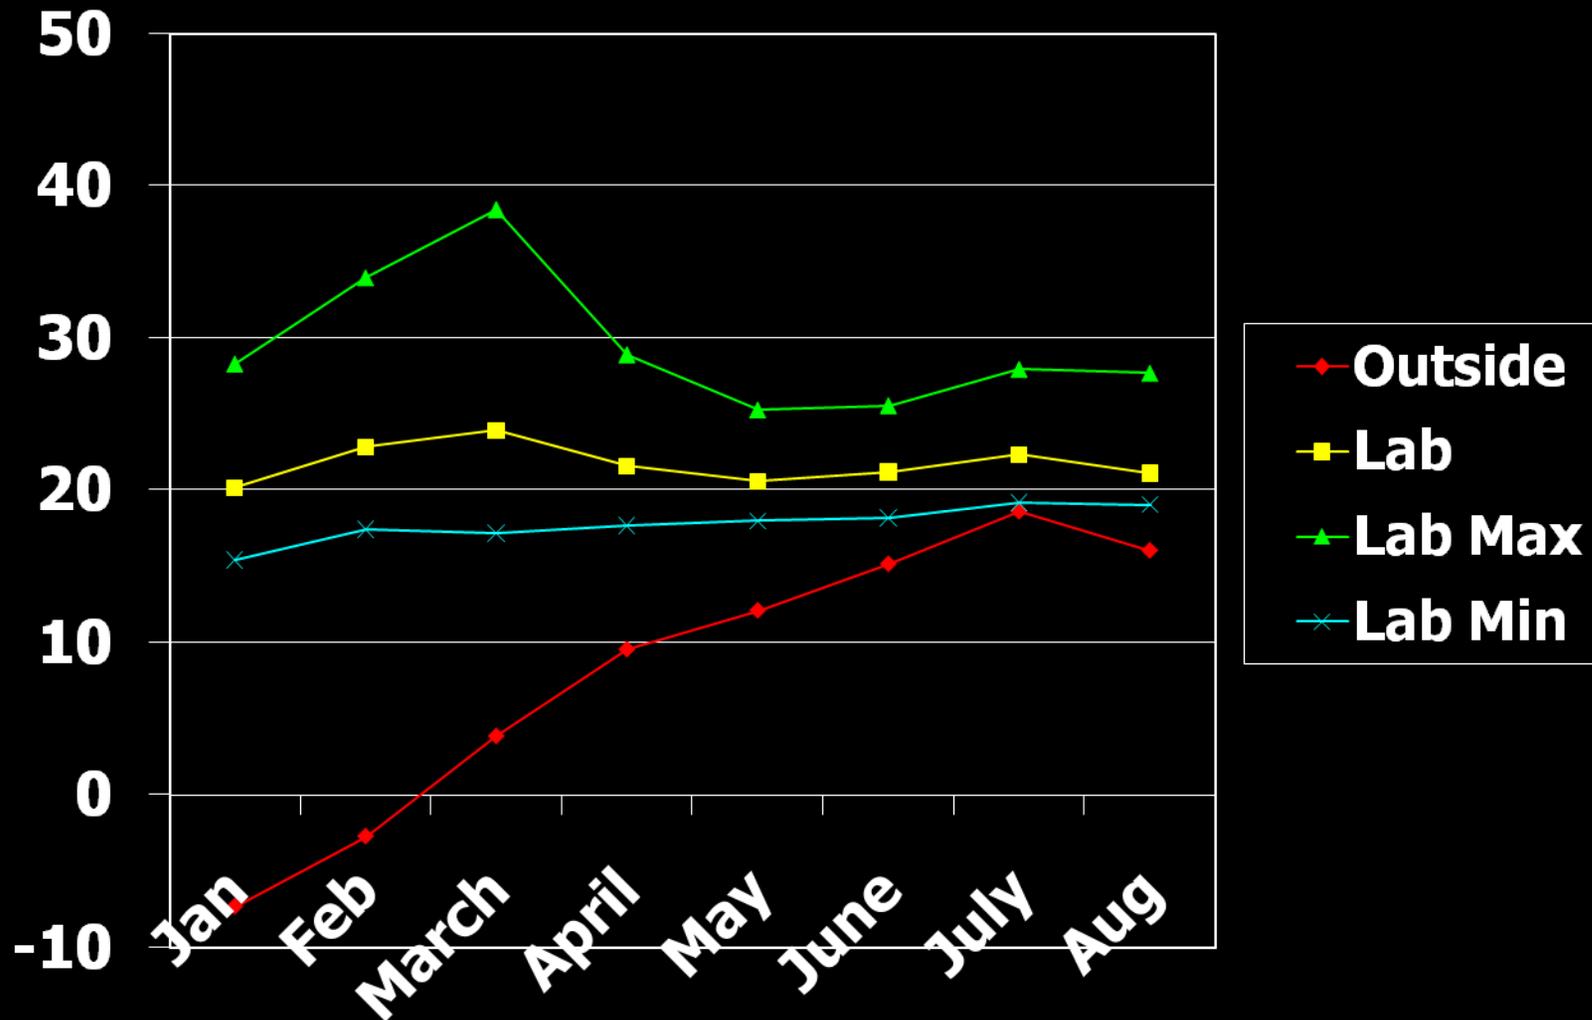
2010 Average Temperatures Lab/Outside

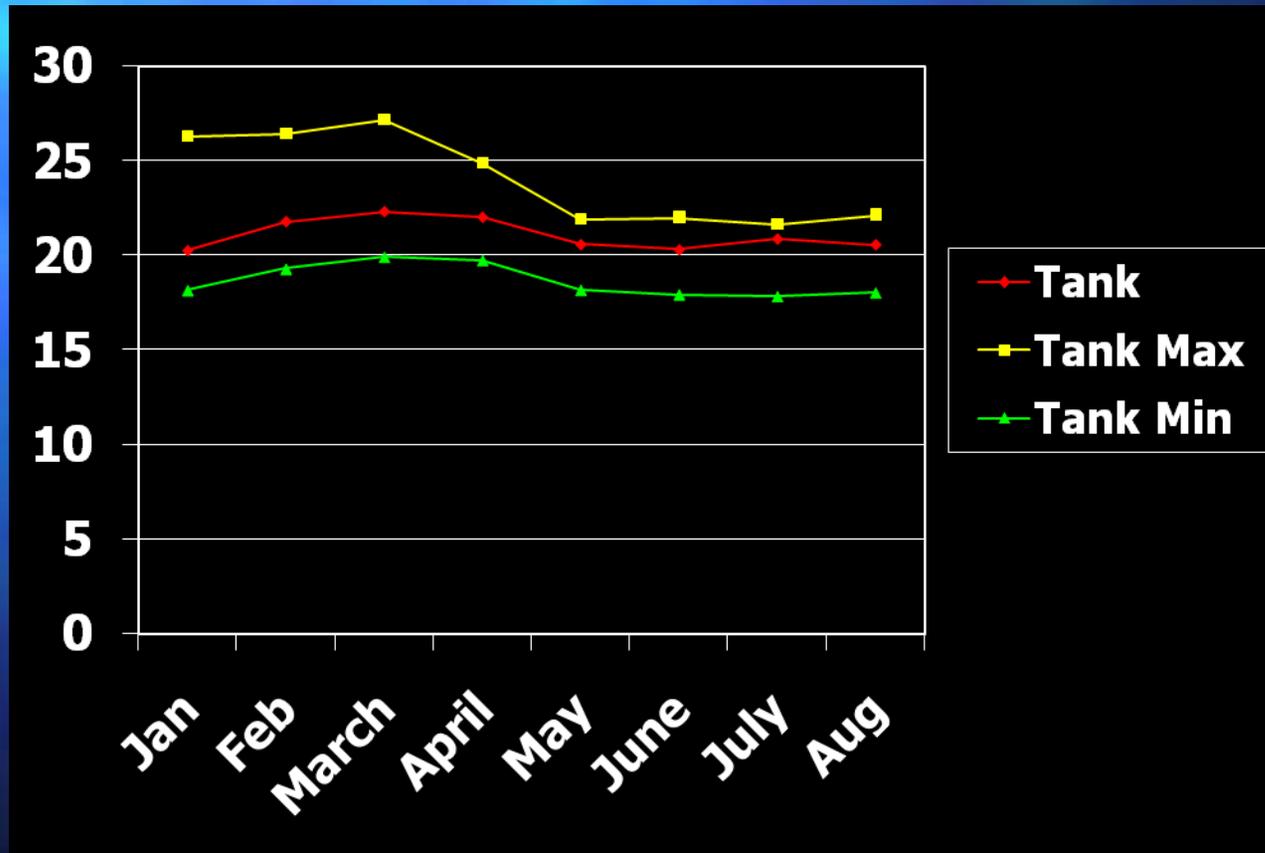
2010 Average Temperatures Process Room

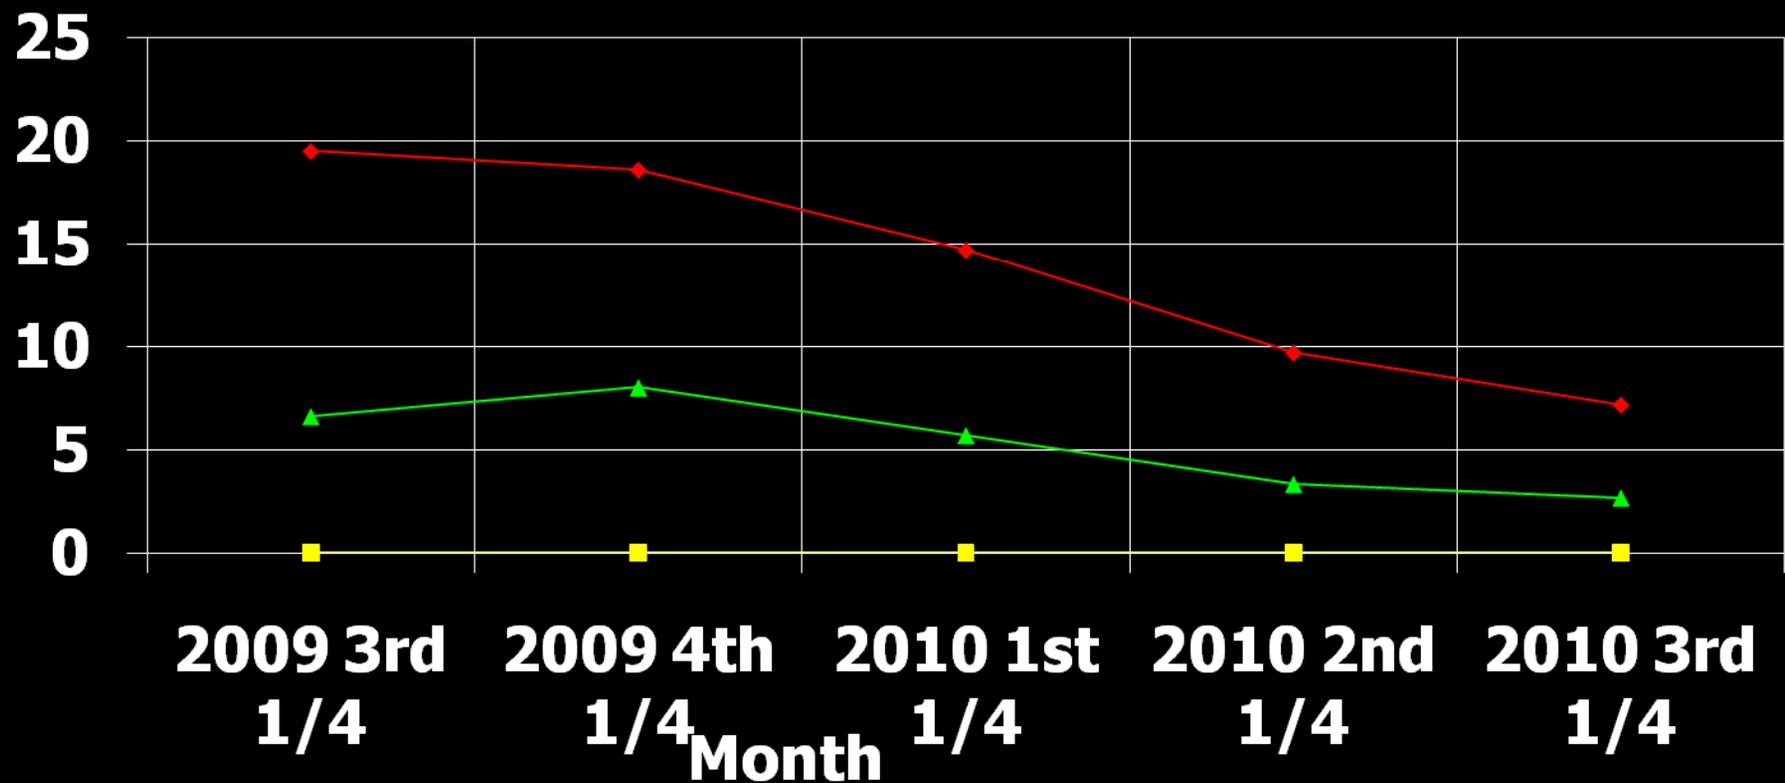
BOD, CBOD & TSS

BOD, CBOD, & TSS Monthly Averages

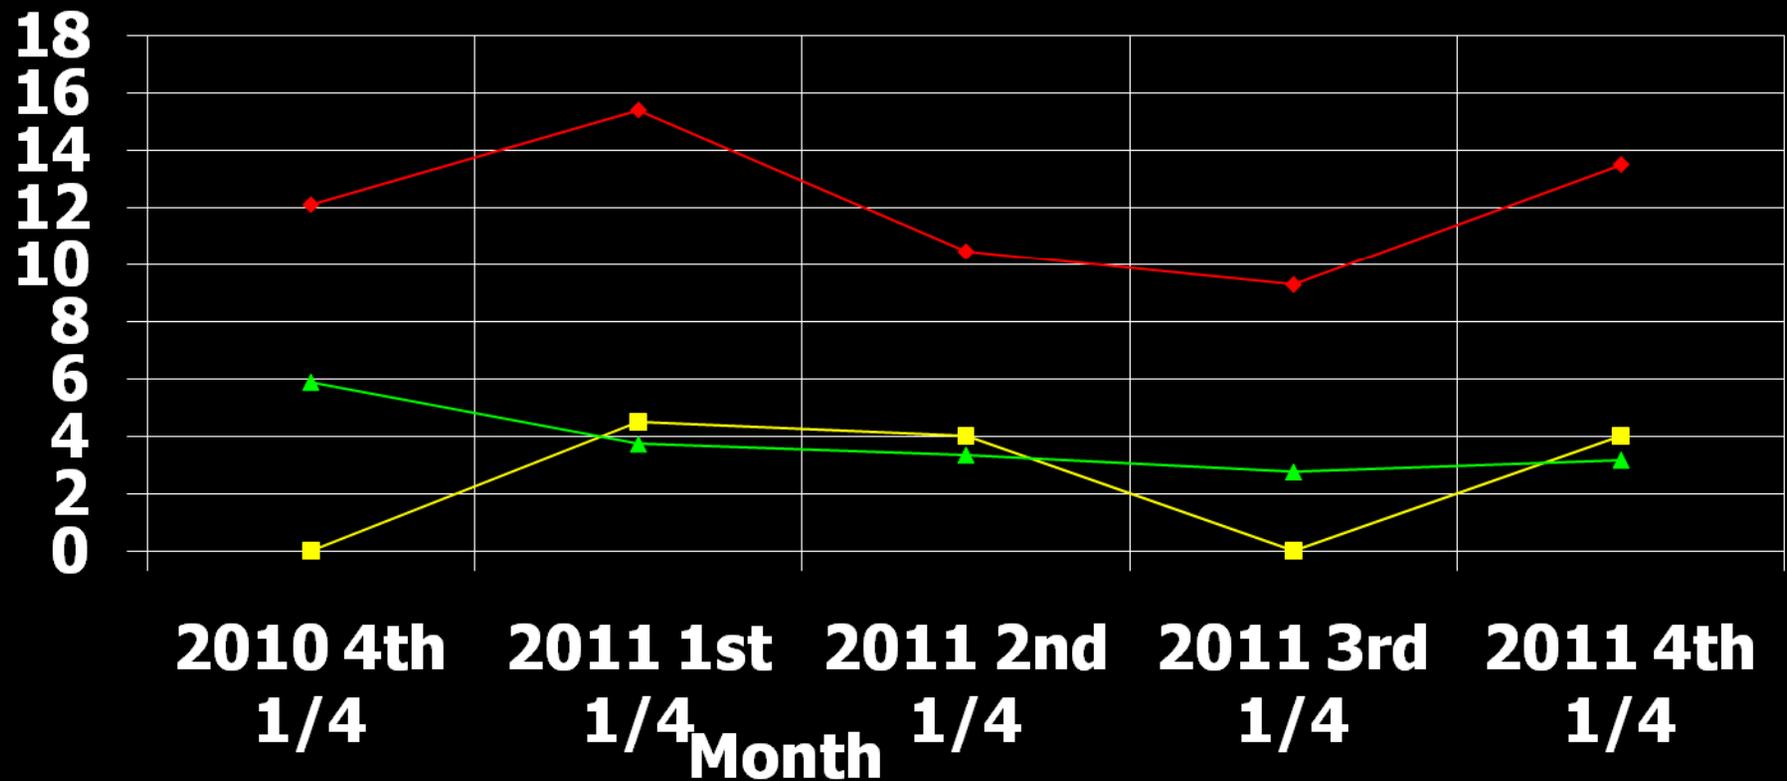
BOD, CBOD & TSS

BOD, CBOD, & TSS Monthly Averages

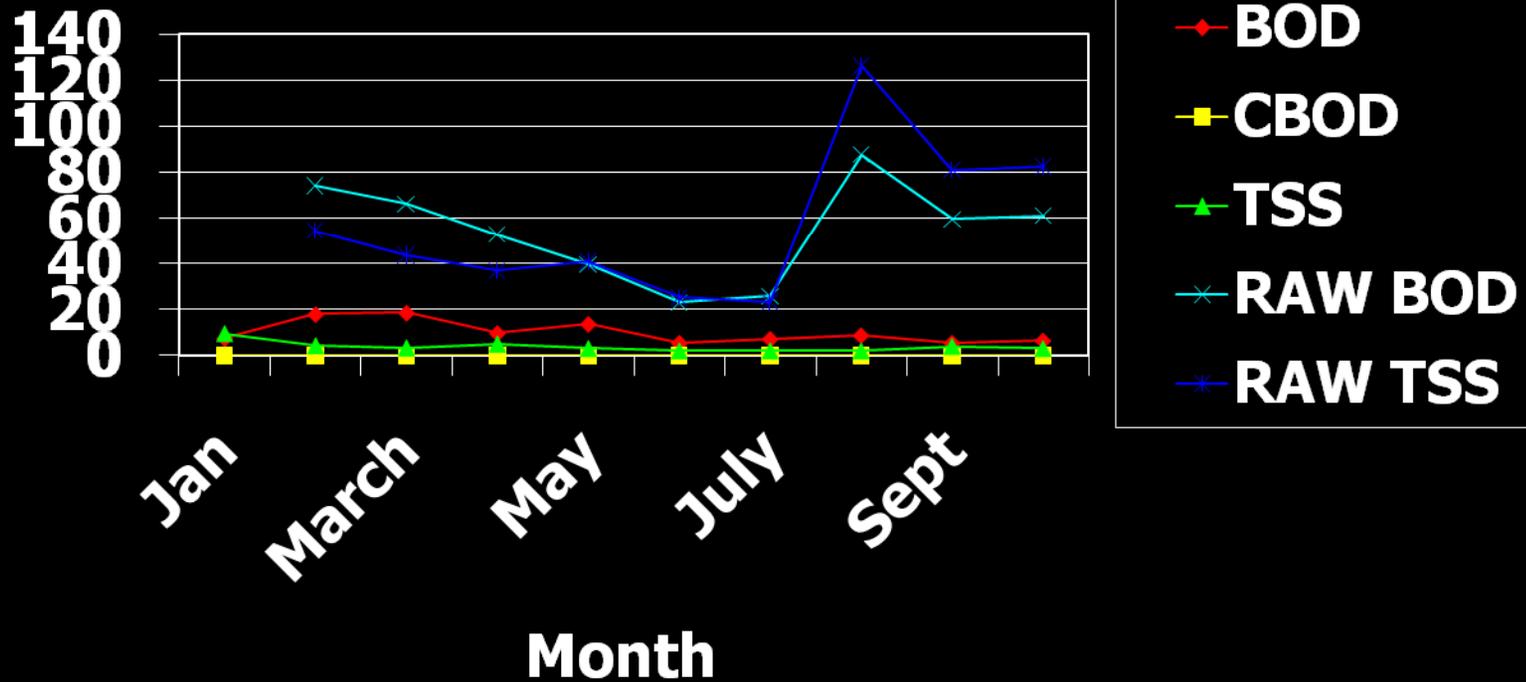
BOD, CBOD & TSS 2010

BOD, CBOD & TSS Monthly Averages
