Crossing ID: WC_0532

NSWA Sturgeon River Watercourse Assessment

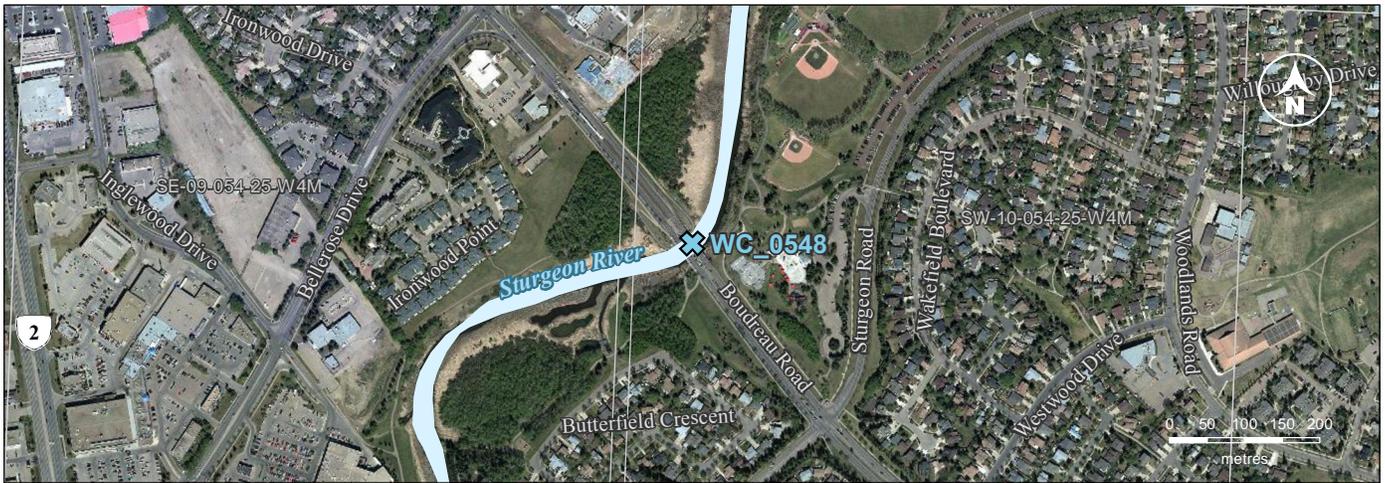
Comments: rip rap the pedestrian walking path then concrete block abutment.

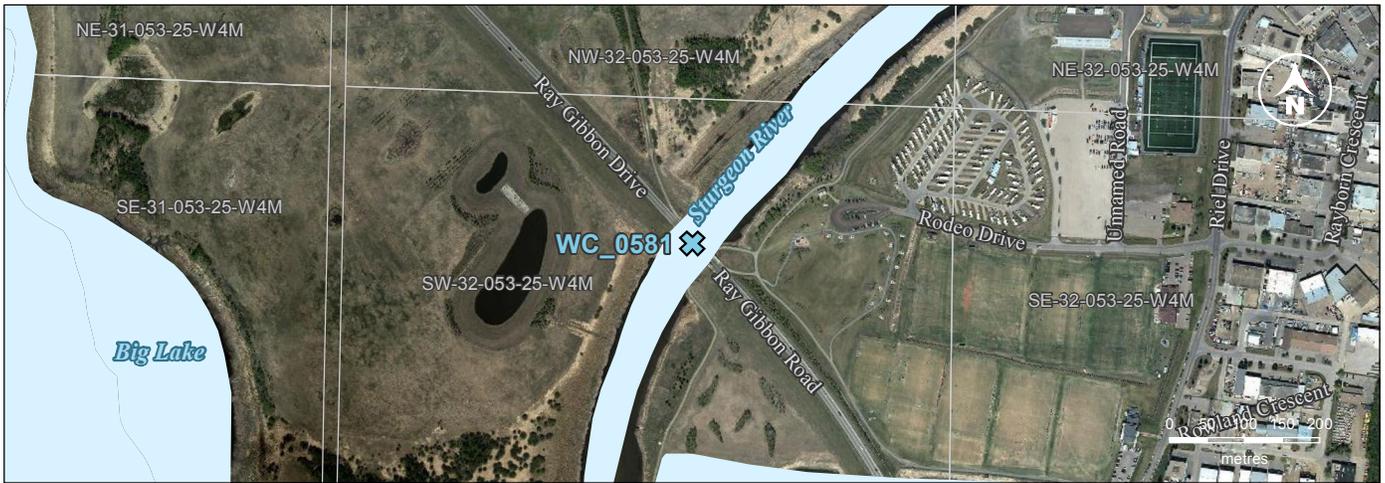
Comments: Walkway flooded, temporary lifted path created. Outlet of Big Lake

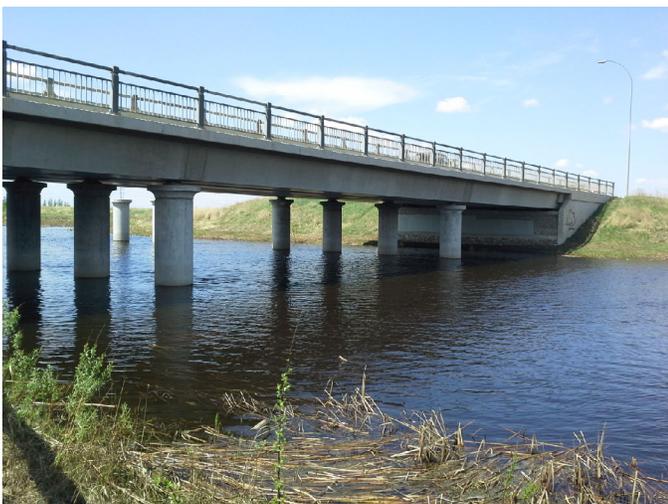
Photo No.: Photos-20180518-190554.jpg
Description: Outlet

Erosion at Site: Yes **Erosion Location (Inlet or Outlet):** Outlet

Erosion Source: Bank Slump

Erosion Extent: Low **Total Erosion Area:** 2 m²

Comments: Riprap missing from southeast side of wingwall and slumping is noted. Site located on Isle Lake. Lots of lakeshore developments. Bridge sits low.

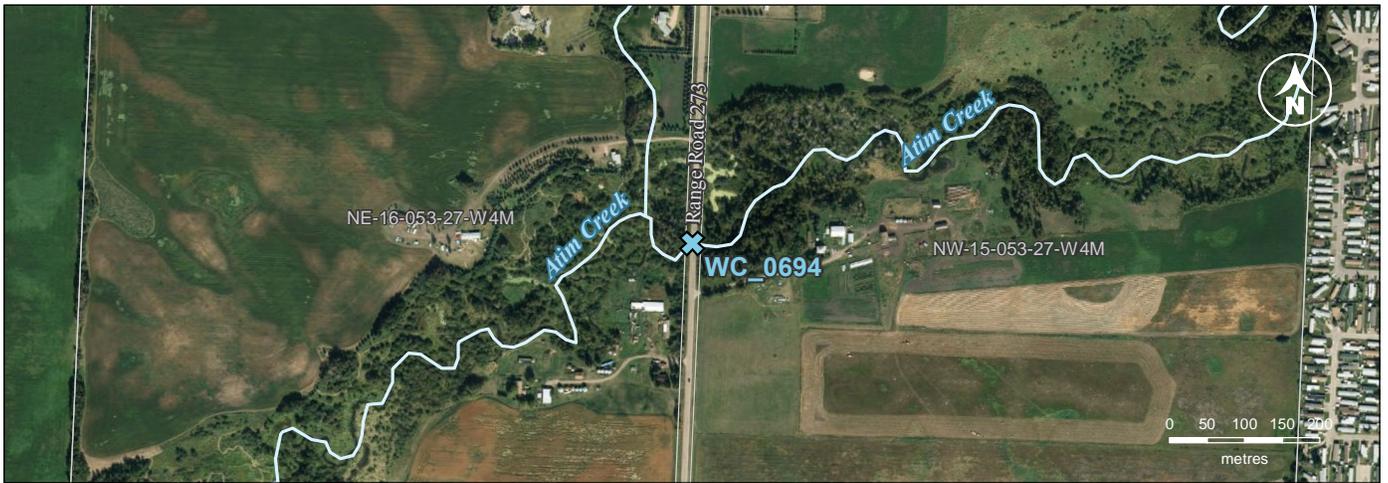
Comments: Riprap present, wingwalls are functioning however there is earth in front and to the sides. This is hard to determine if its top of stream bank.

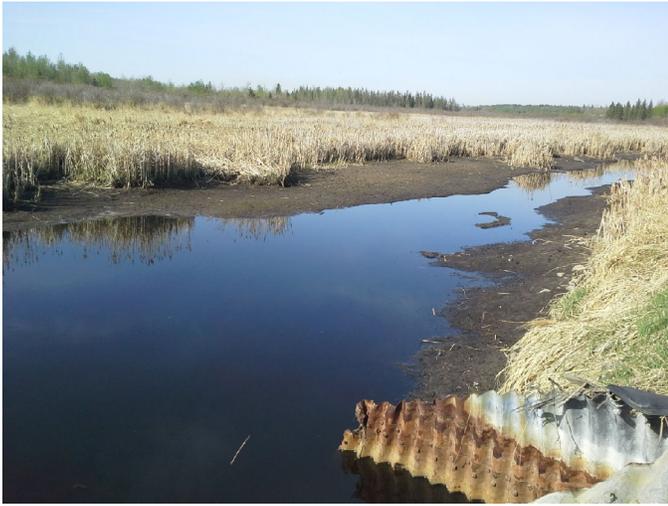
Photo No.: Photos-20180514-153206.jpg
Description: Upstream

Comments: inlet of WC_0790, wetland area. rr 23 just redone. old silt fences around culvert. Low flow.

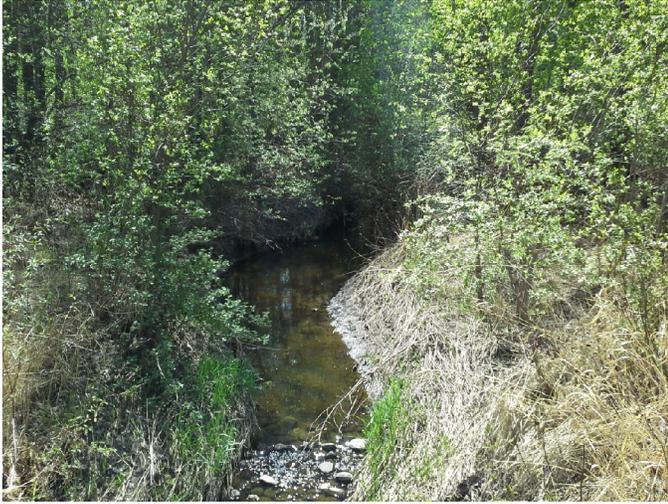
Photo No.: Photos-20180515-185122.jpg
Description: Upstream

Fish Passage Assessment: No Concerns
Emergency Repair Required?: No
Overall Risk: Low
Comments: Rocks, of various sizes, visible throughout culvert channel. Culvert seems large for the size of the stream.

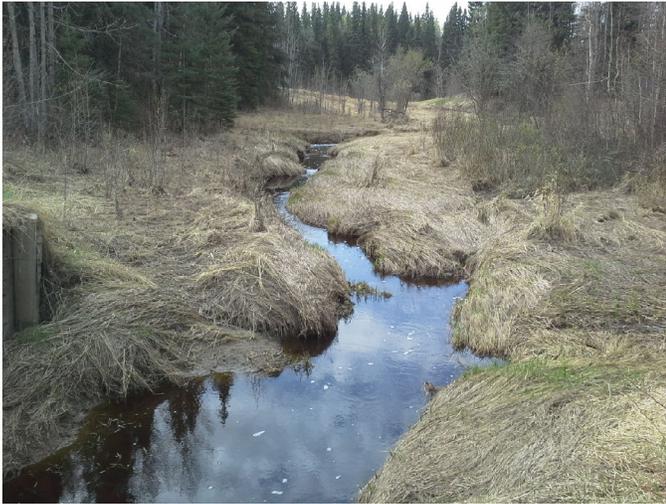
Photo No.: Photos-20180509-175223.jpg
Description: Upstream

Comments: NW wing wall has vegetation coming around it, looks stable. Lots of downed barb wire.
