Crossing ID: WC_0854

NSWA Sturgeon River Watercourse Assessment

Inspection Date: May 15, 2018

Watercourse Name: Atim Creek

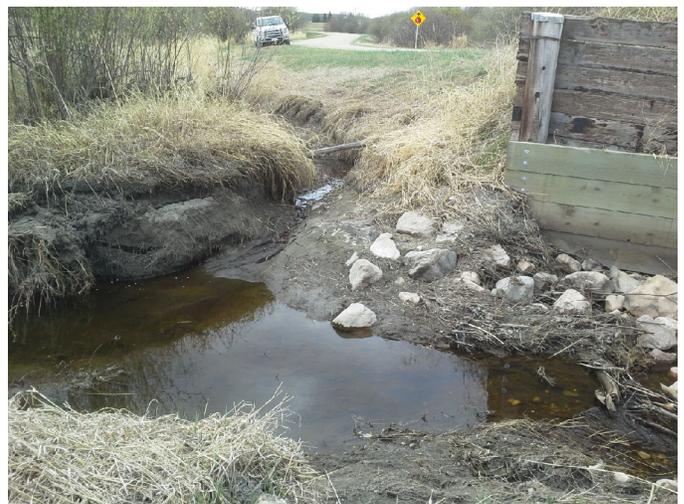
Wingwall Functioning?: Yes - in good condition but materials eroding from the side

Comments: Area of secondary inflow has brought material to in front of wingwall.

Photo No.: Photos-20180509-172106.jpg
Description: Secondary inflow

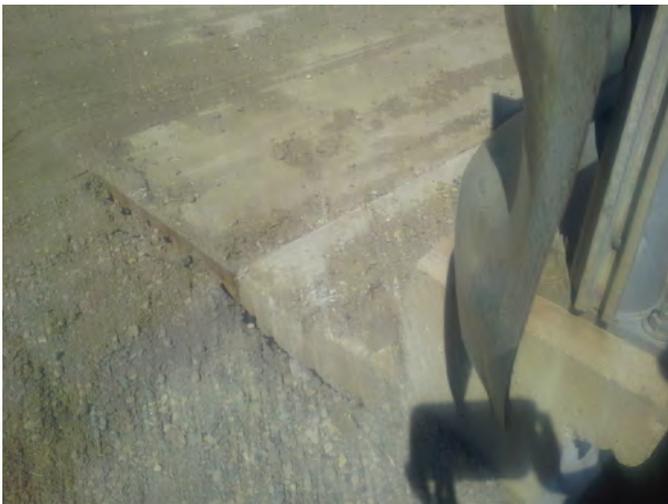
Comments: Fence in water at outlet, possibility to create blockage. This crossing was not part of the initial assessment, however it was included. Landowner near by mentioned the bridge and said it was upgraded winter 2017-2018. Capacity of bridge has been reached and difficult to determine structural integrity. Bridge deck is higher than road, causing a dangerous bump when driving over the bridge.

Photo No.: Photos-20180508-182809.jpg
Description: road and bridge deck not even

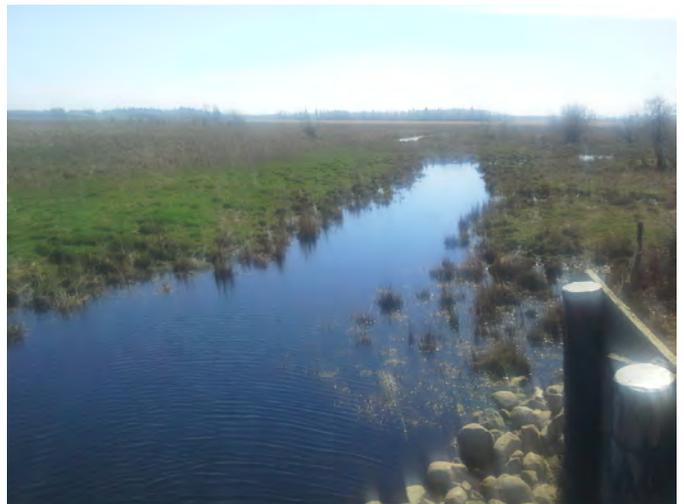
Photo No.: Photos-20180508-182614.jpg
Description: Outlet

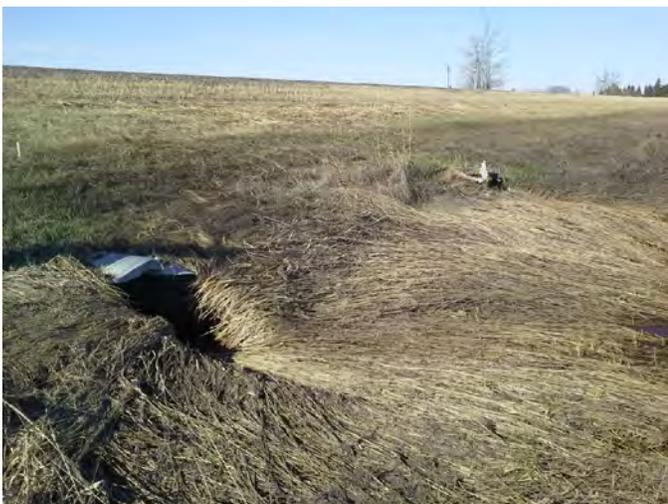
Comments: cultivated field "upstream" had serious flooding this year (as per land owner said). there was water vortices's trying to drain water from the area. landowner said a third or larger culverts should be there. 2/4 culverts damaged. Vegetation at inlet causing blockage. No defined channel upstream of culverts. Area seems more of a storm water catchment.

Photo No.: Photos-20180507-154401.jpg
Description: Inlet

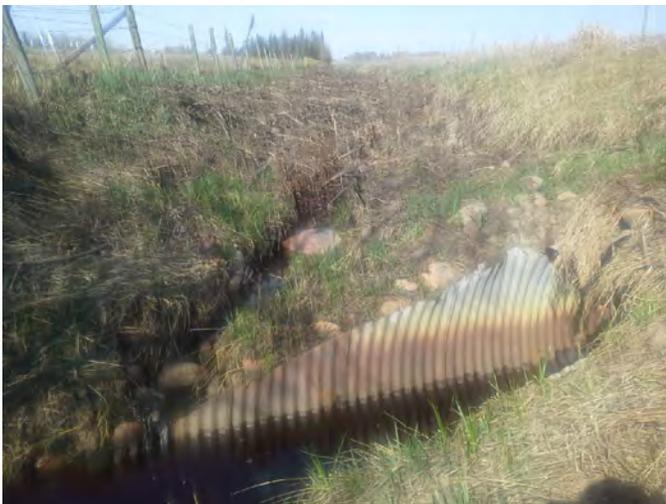
Photo No.: Photos-20180508-162642.jpg
Description: Erosion

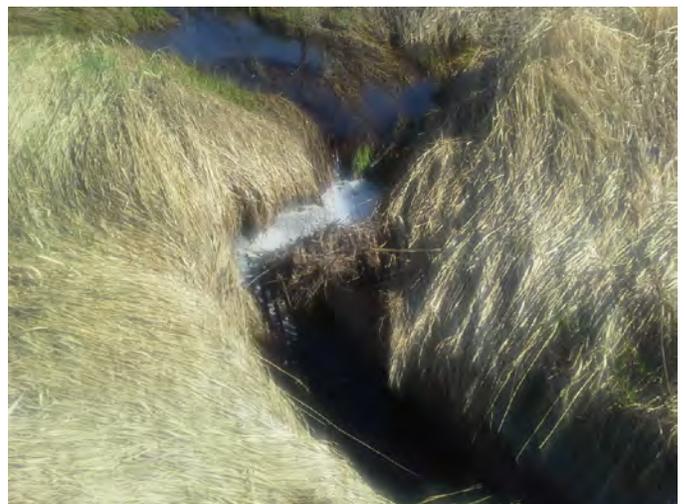
Photo No.: Photos-20180508-162828.jpg
Description: Blockage

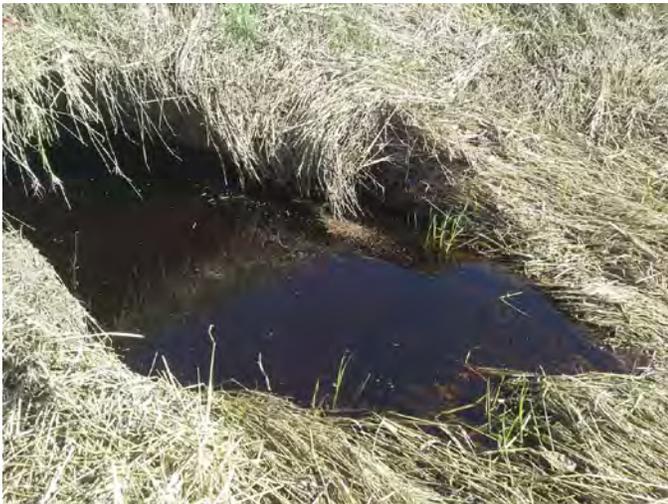
Comments: Culvert 1 (N/S along road): 10% blockage by fence post in water collecting veg, outlet pool 0.53m. Culvert 2 (diagonal): cement bottom at outlet, pool at outlet is formed by cement 0.25m. Damage on this culvert. Very close to gravel road. Average outlet pool depth: 0.39m.

Photo No.: Photos-20180507-162552.jpg
Description: Culvert 2 - Cement bottom with pool

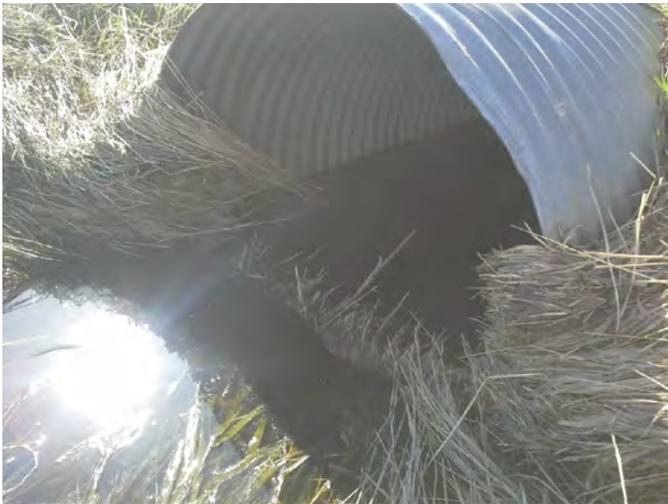
Photo No.: Photos-20180507-162947.jpg
Description: Culvert 1 - Blockage In

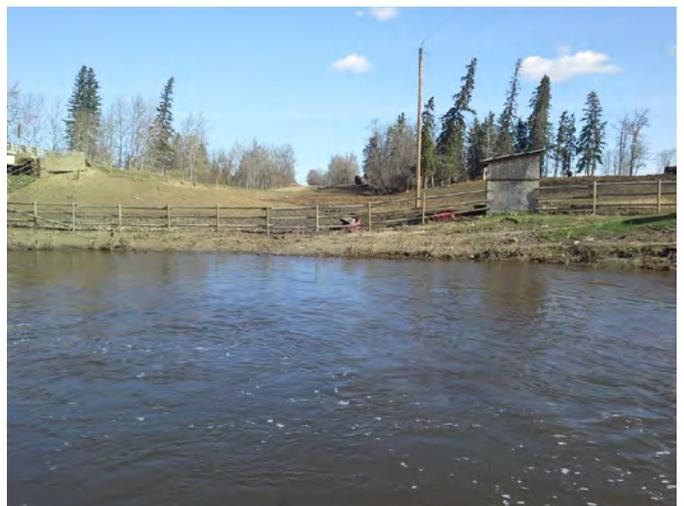
Comments: Cattle access created erosion along riparian area of river. This area is now non vegetated.

Photo No.: Photos-20180504-164539.jpg
Description: Erosion (Cattle Pen)

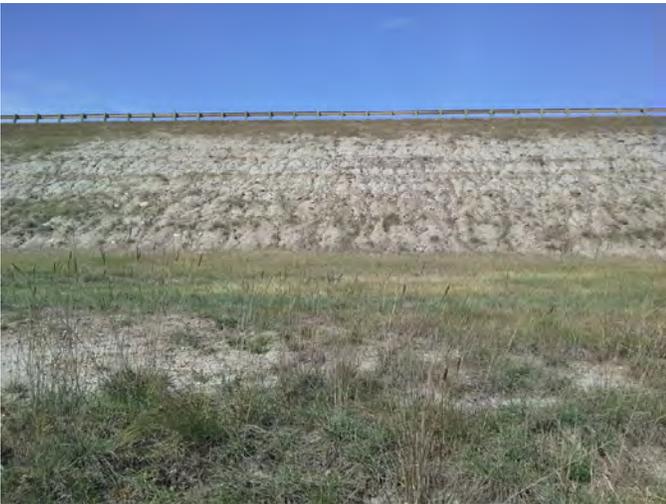
Photo No.: Photos-20180504-170322.jpg
Description: Erosion

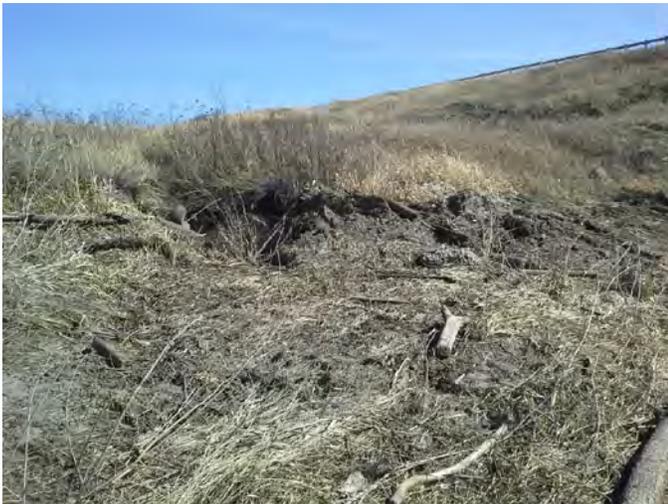
Photo No.: Photos-20180504-171604.jpg
Description: Erosion Bank Slump

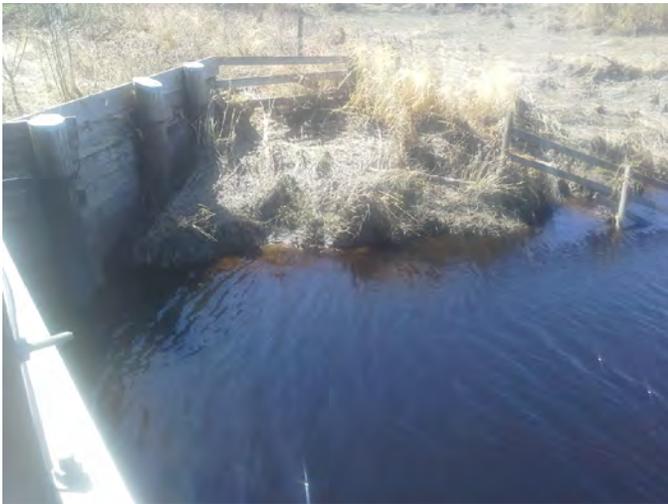
Comments: bridge is at its capacity. Structural integrity is hard to determine. There is a fence in the water. Biggest concern is the unrestricted access that cattle have to the water. The channel banks are eroded and flattened out cattle prints. Erosional evidence of soil creating a peninsula in water.

Photo No.: Photos-20180508-184851.jpg
Description: Erosion Ditch Slumping

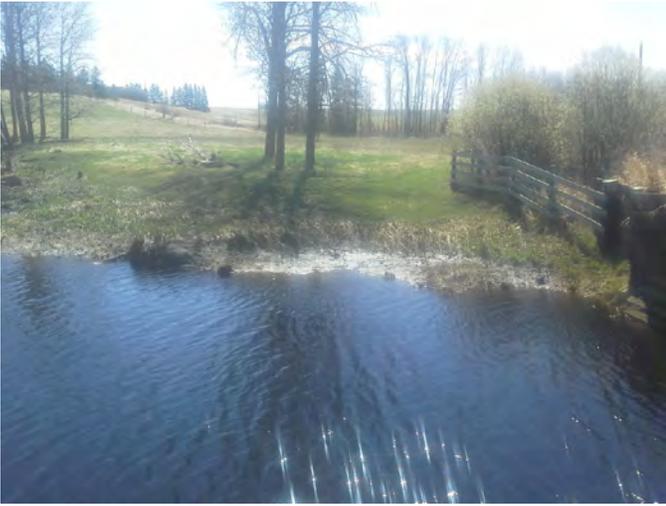
Photo No.: Photos-20180508-185041.jpg
Description: Erosion - Cattle Access

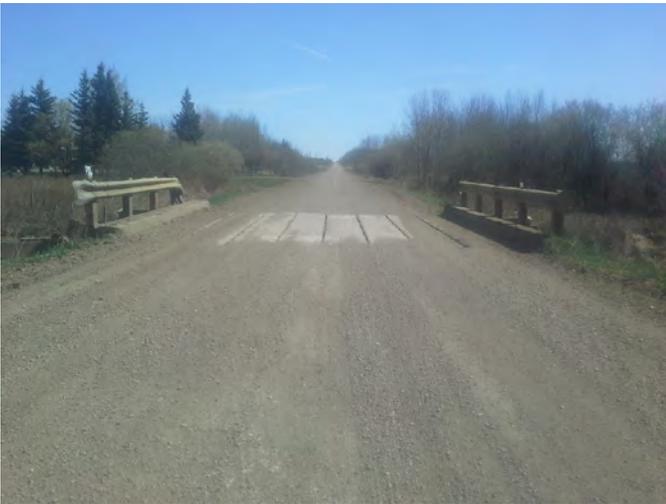
Photo No.: Photos-20180508-190503.jpg
Description: Deck

Structural Problems: Damaged Guardrail, Other - large spaces between pavement deck slates, missing abutment piling, wingwall not secure

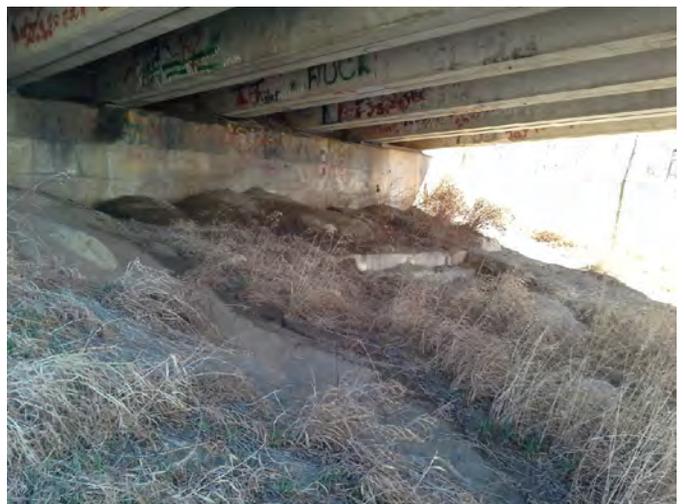
Photo No.: Photos-20180504-180131.jpg
Description: Erosion

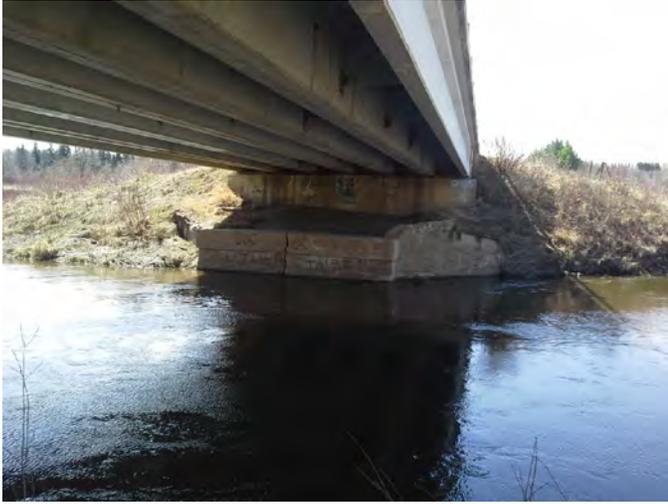
Photo No.: Photos-20180504-180156.jpg
Description: Erosion

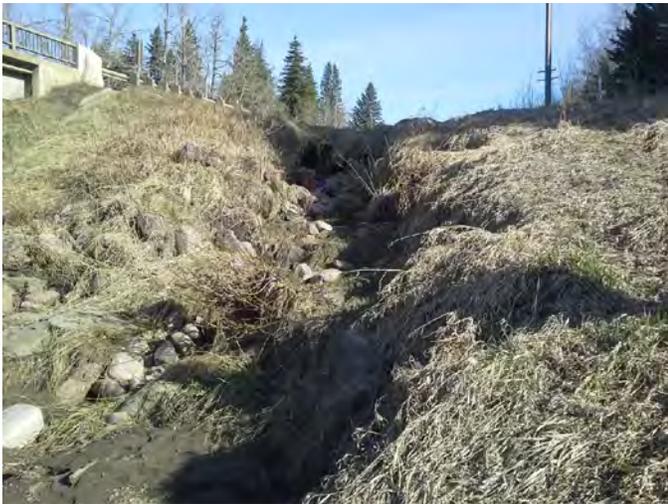
Comments: Heavy Erosion

Photo No.: Photos-20180504-153124.jpg
Description: Erosion

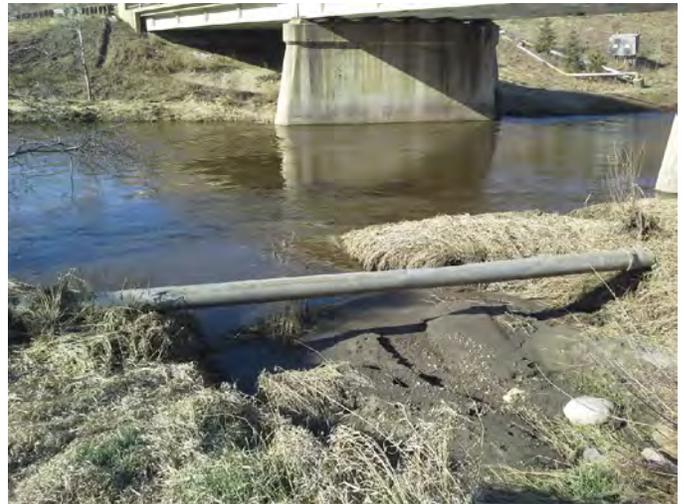
Photo No.: Photos-20180504-153148.jpg
Description: Erosion

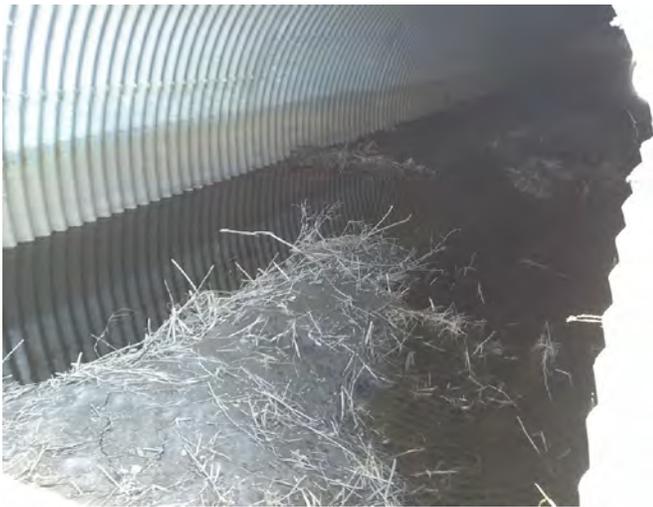
Photo No.: Photos-20180507-194508.jpg
Description: Bank slump in culvert

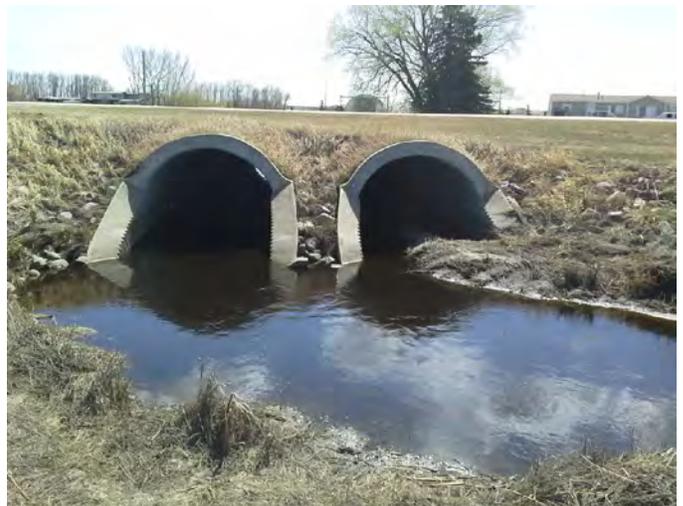
Photo No.: Photos-20180507-194934.jpg
Description: Sediment in

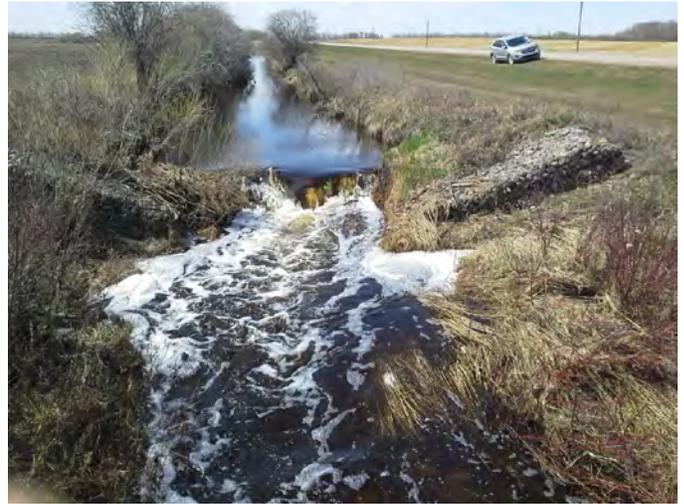
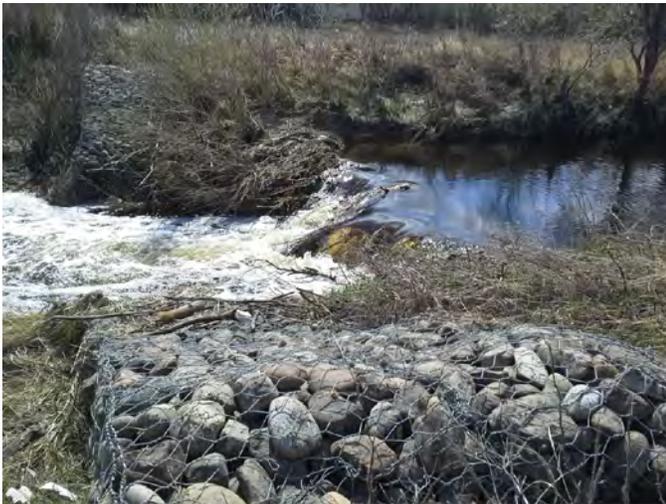
Comments: Gabions located approximately 10m upstream of bridge is causing the stream to bottleneck creating higher velocity of water and blockage concerns for fish to travel upstream. The middle log piling along the southern abutment wall is pulling away from the wall.

Photo No.: Photos-20180507-200523.jpg
Description: Gabion

Photo No.: Photos-20180507-200601.jpg
Description: Gabion

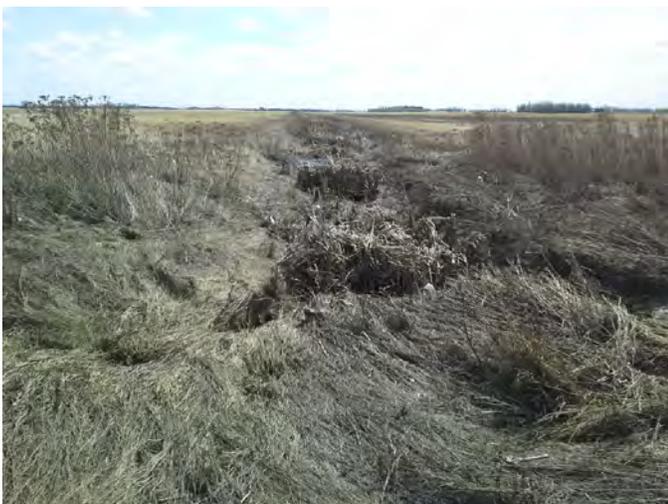
Photo No.: Photos-20180507-211515.jpg
Description: 32m from culvert is defined channel

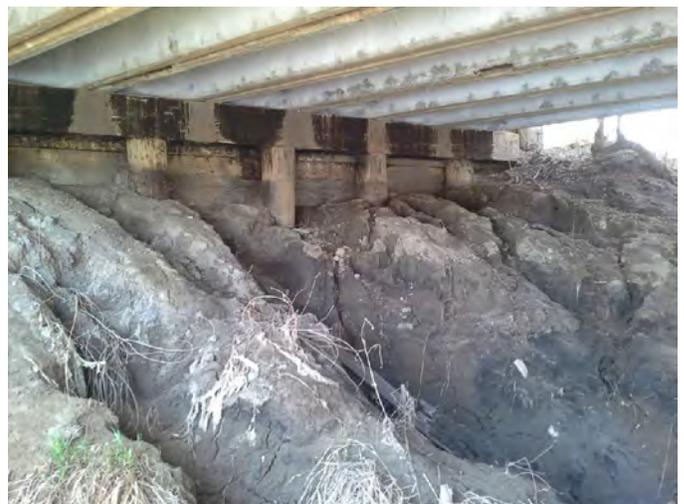
Photo No.: Photos-20180504-193350.jpg
Description: Erosion West

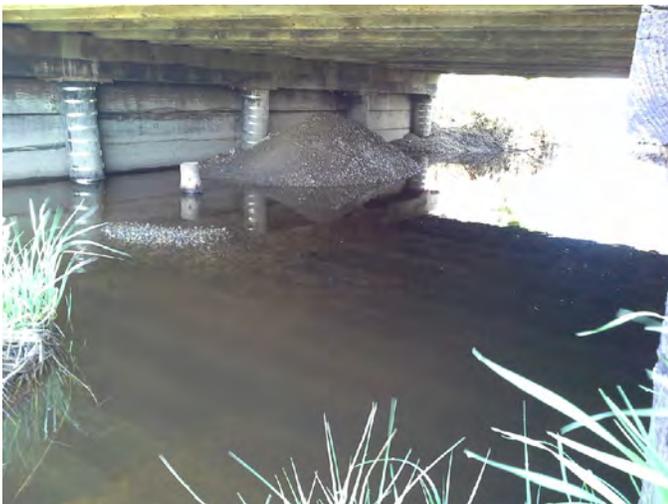
Photo No.: Photos-20180518-151547.jpg
Description: Sediment buildup

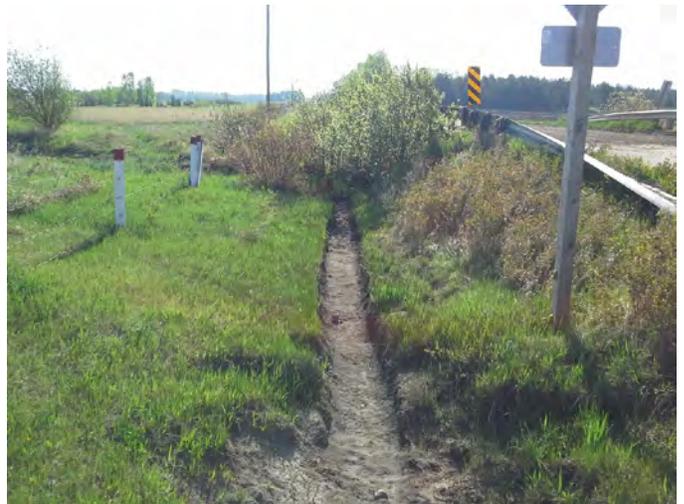
Photo No.: Photos-20180518-151658.jpg
Description: Ditch drainage

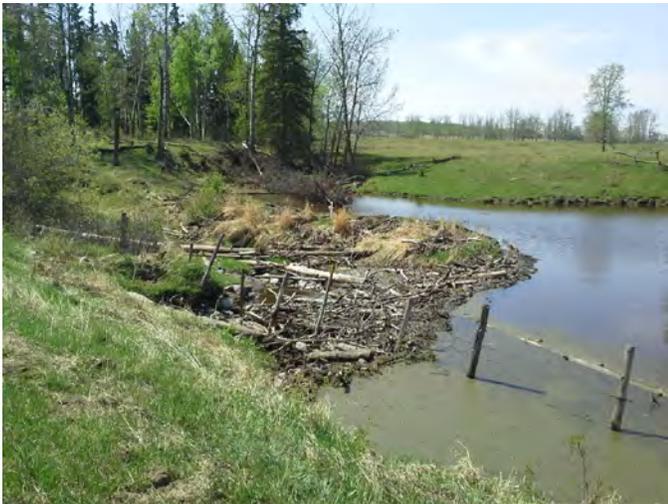
Photo No.: Photos-20180514-184947.jpg
Description: Beaver dam

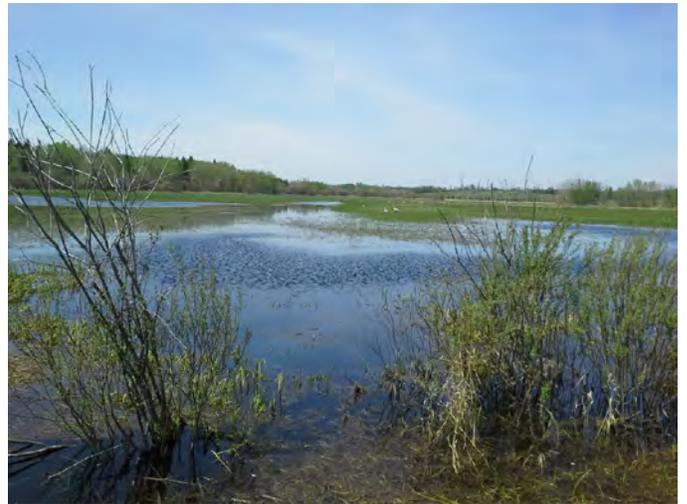
Comments: Low laying area with flooding, riparian areas and large grassy wetlands. Road where culvert was, very low. Road is probably at risk for flooding. Could not find the outlet of culvert, completely submerged. Trumpeter swans noted utilizing habitat. GPS location was incorrect, actually location was 25m south.

Photo No.: Photos-20180514-193507.jpg
Description: Swans

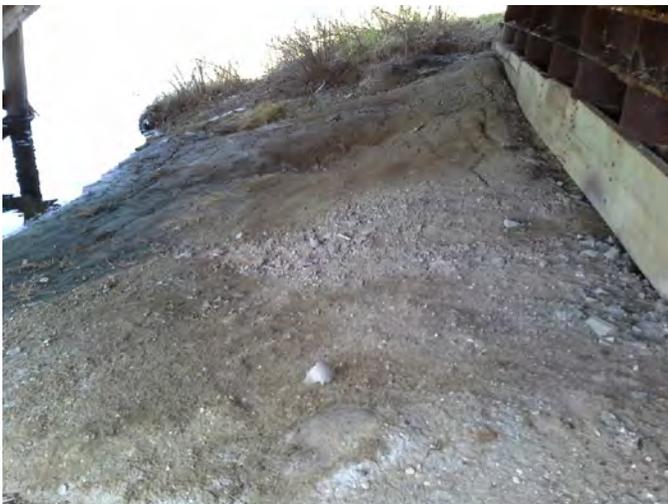
Comments: Non vegetated fill slopes. Erosional concern.

Photo No.: Photos-20180514-195523.jpg
Description: Erosion

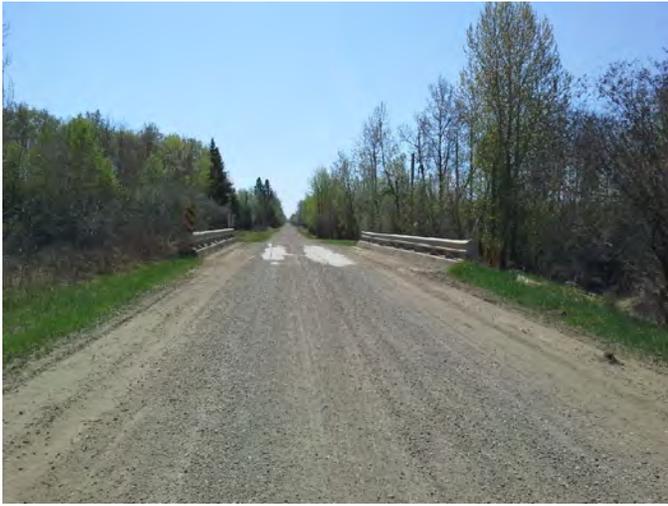
Comments: Erosional concerns with fill slope. Abutment wall on the north side looks like its angling in.

Photo No.: Photos-20180511-192209.jpg
Description: Deck

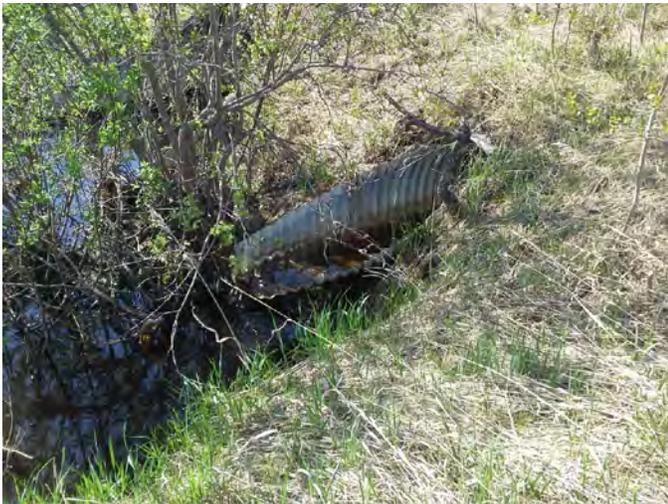
Comments: Smaller culvert is converging to inlet of Carrot Creek and has an outlet gap of 0.45m, however it has no water at time. Second smaller culvert is ditch drainage from east side of road which collects runoff from manicured lawn and drains into Carrot Creek. Area near water smells.

Photo No.: Photos-20180518-163415.jpg
Description: Outlet smaller culvert is ditch drainage

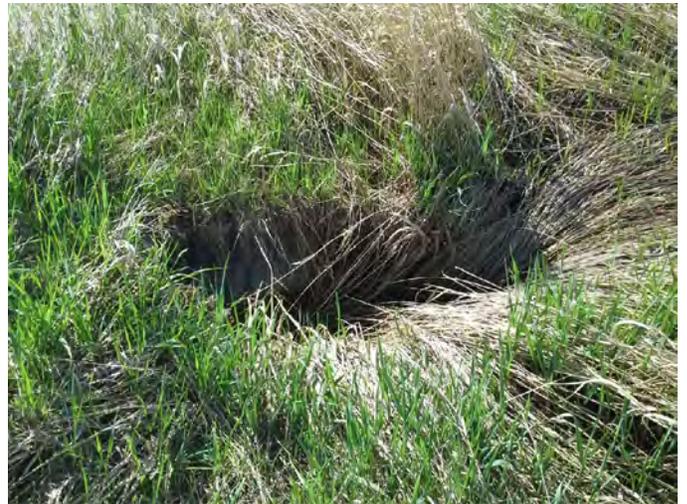
Photo No.: Photos-20180518-163618.jpg
Description: Smaller culvert inlet

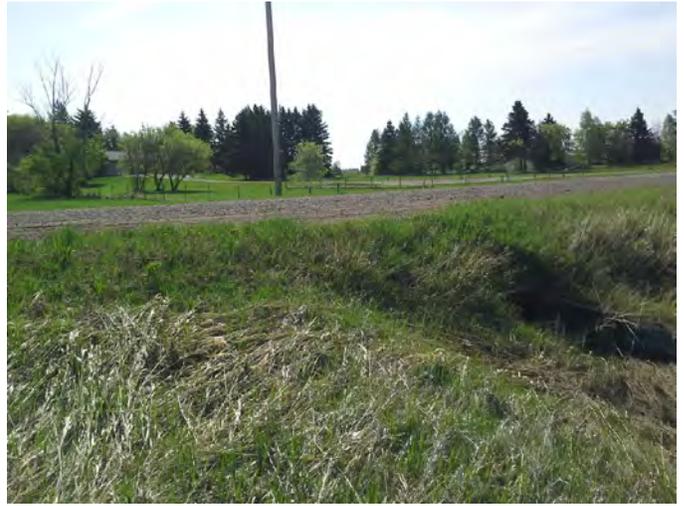
Photo No.: Photos-20180518-164044.jpg
Description: Drainage ditch culvert 10m from outlet which flows from a manicured lawn

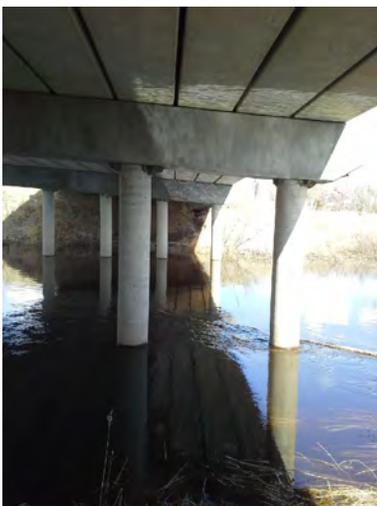
Photo No.: Photos-20180507-213848.jpg
Description: Erosion

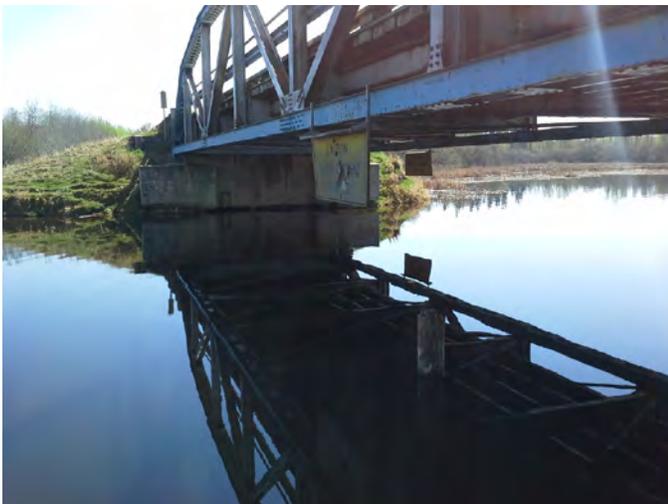
Photo No.: Photos-20180511-171930.jpg
Description: Erosion under abutment

Comments: Material moving around wingwall. Abutments are in stream with lumber surrounding it and against fill slope. Water can get between fill slope and abutment lumber wall causing fill slope erosion to occur.

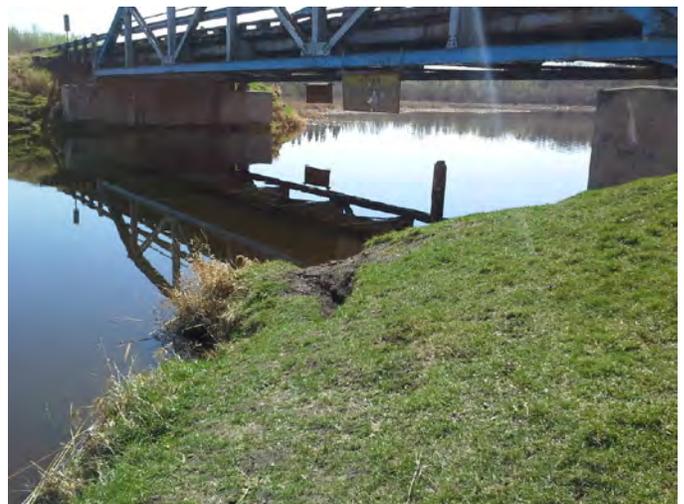
Photo No.: Photos-20180511-172039.jpg
Description: Slumping

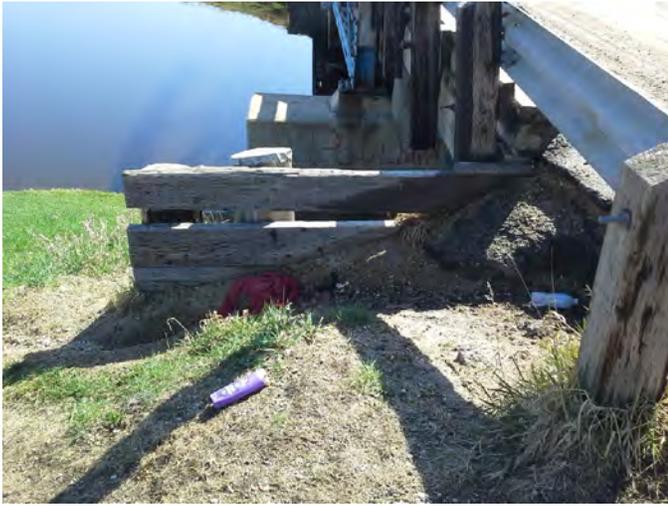
Photo No.: Photos-20180511-172301.jpg
Description: Ditch gully / road materials

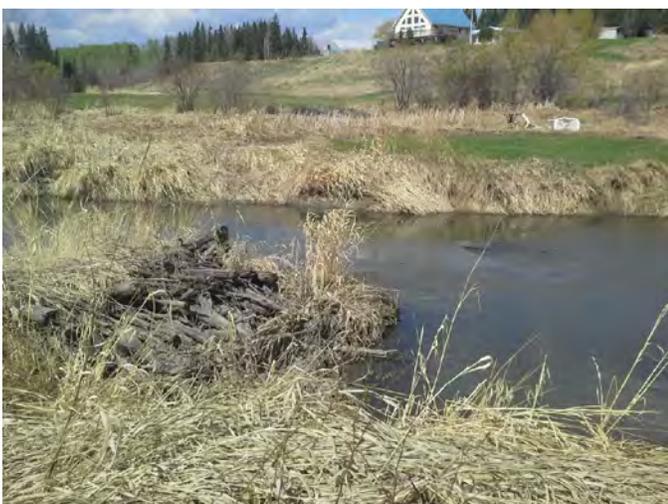
Photo No.: Photos-20180511-210602.jpg
Description: Old beaver dam

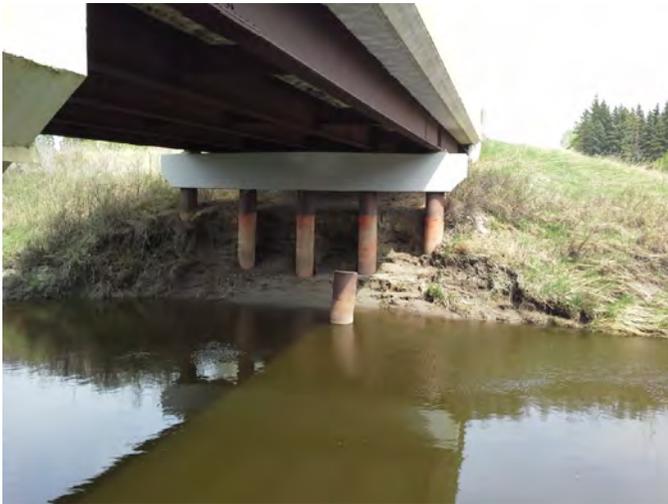
Photo No.: Photos-20180516-210502.jpg
Description: Erosion

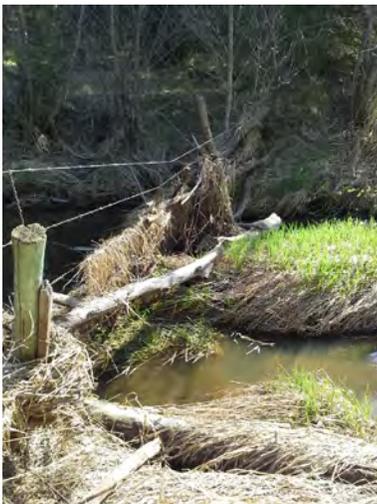
Photo No.: Photos-20180514-165952.jpg
Description: Fencing downstream

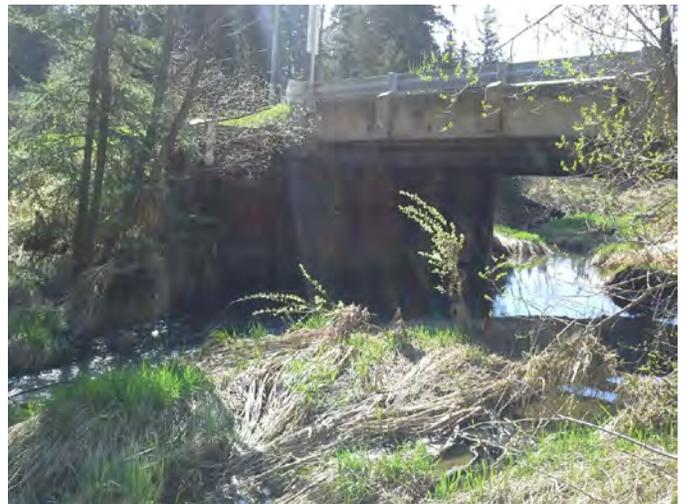
Abutment Functioning?: No - in good condition but materials eroding from underneath

Comments: Materials eroding from under abutment wall. Small beaver dam noted approximately 25m upstream. This crossing is downstream of a gravel wash pit.

Photo No.: Photos-20180514-170011.jpg
Description: Under abutment showing

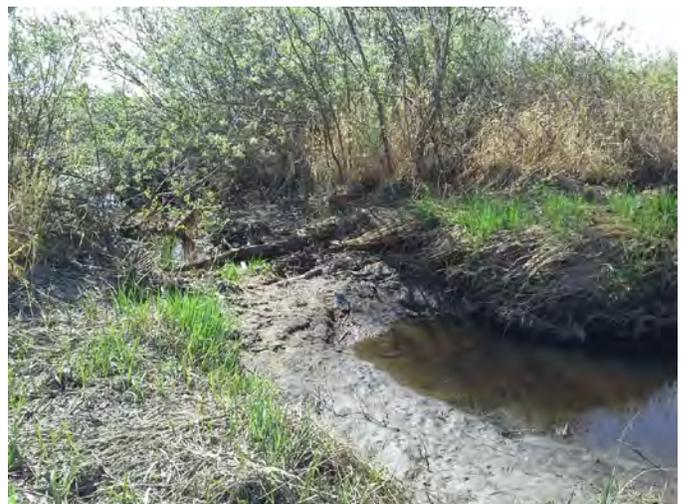
Photo No.: Photos-20180518-173436.jpg
Description: Old beaver dam?

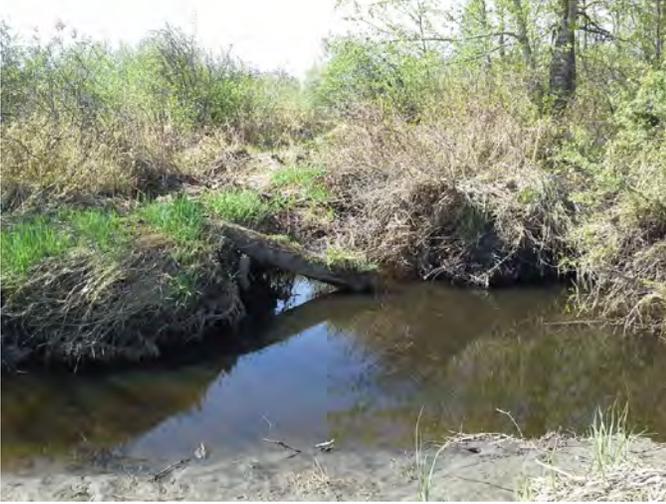
Photo No.: Photos-20180518-173452.jpg
Description: Old beaver dam?

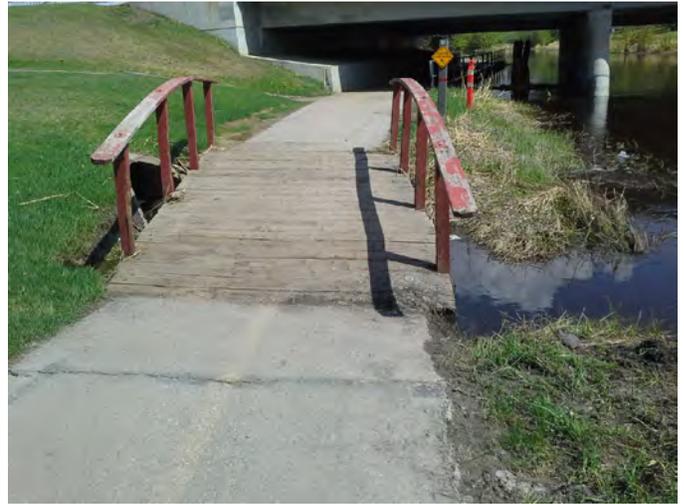
Comments: Bankfull width and wetted width are very similar. Water level could rise and flood sidewalks and enter stormwater drainage.

Photo No.: Photos-20180518-200539.jpg
Description: Storm water drainage

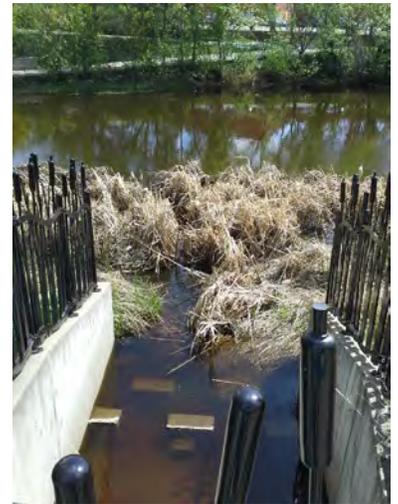
Photo No.: Photos-20180518-195736.jpg
Description: Storm water discharge

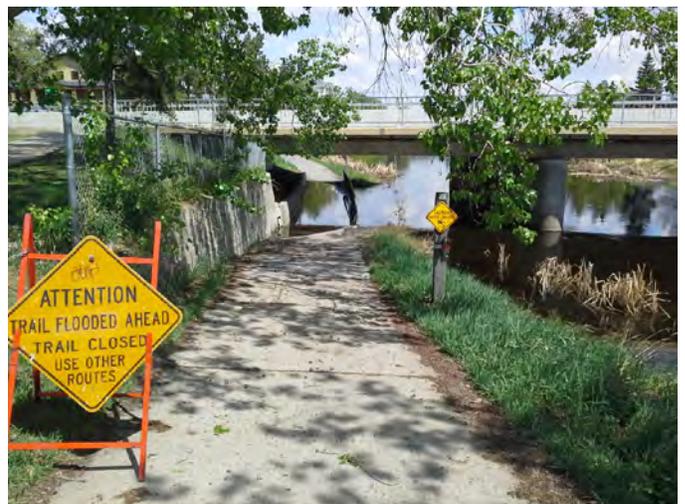
Comments: low laying area. River exceeding its banks. Flooding onto sidewalk. There seems to be some separation of the cement abutment wall to the cement armour. There is no grader markers or bridge reflectors.

Photo No.: Photos-20180518-195819.jpg
Description: Flooding

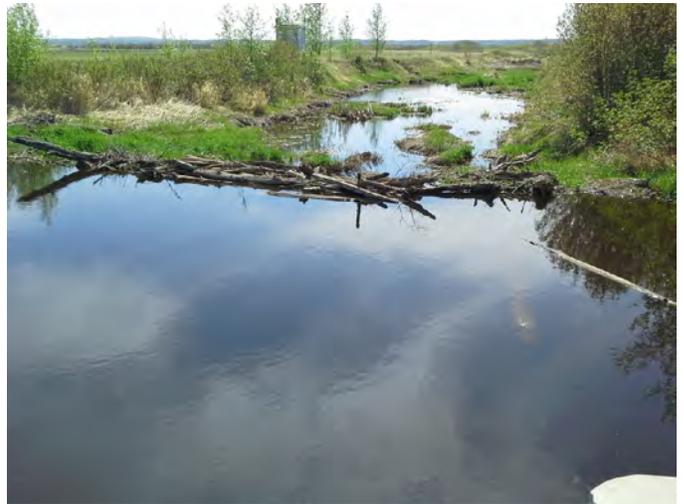
Comments: Happy beaver in area. Dam approx 5 meters downstream from bridge at outlet. Looks to be about 10% of water able to get through. Water is back pooling to the point of exceeding its bankfull width around bridge. Water is moving behind wingwalls.

Photo No.: Photos-20180518-183940.jpg
Description: Beaver dam downstream

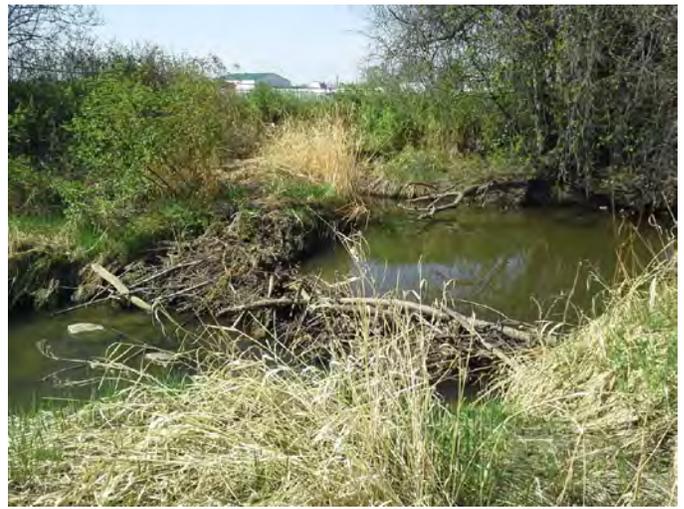
Comments: beaver dam leading to fish passage concerns. Ripple up and downstream of bridge caused by larger rocks in water (unsure if natural or not). Rip rap on southside of bridge and not northside.

Photo No.: Photos-20180516-171548.jpg
Description: Beaver dam

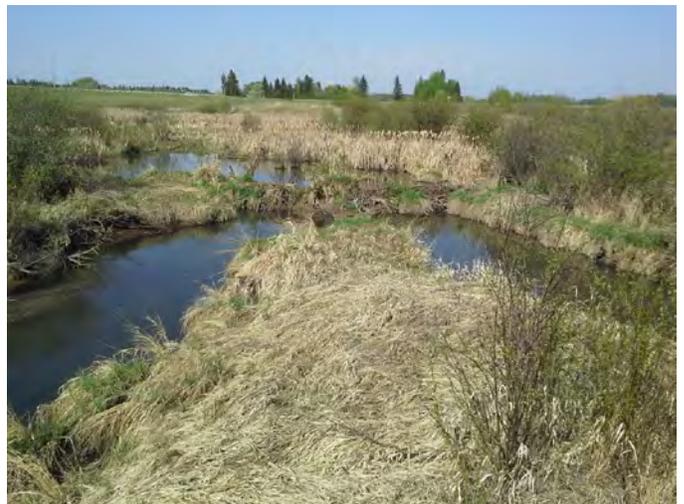
Comments: Beaver dam upstream approx 25m. water has diverted around or a split channel was historically there. Beaver dam down stream is small, approx 30m from culvert

Photo No.: Photos-20180516-163212.jpg
Description: Beaver dam upstream

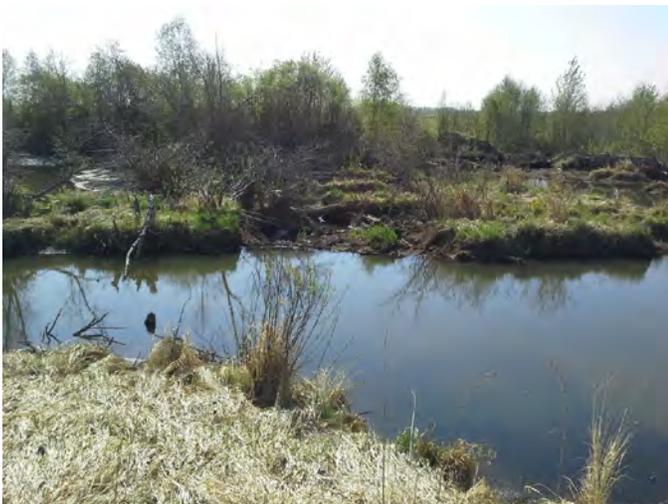
Photo No.: Photos-20180516-163530.jpg
Description: Beaver dam downstreams

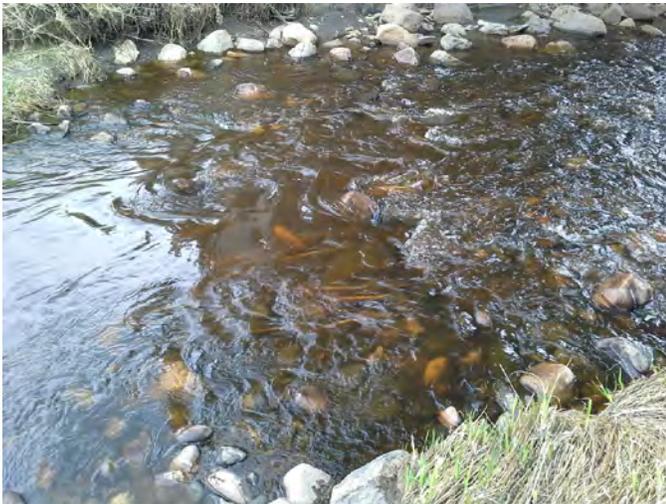
Photo No.: Photos-20180509-195408.jpg
Description: White suckers in Ripple

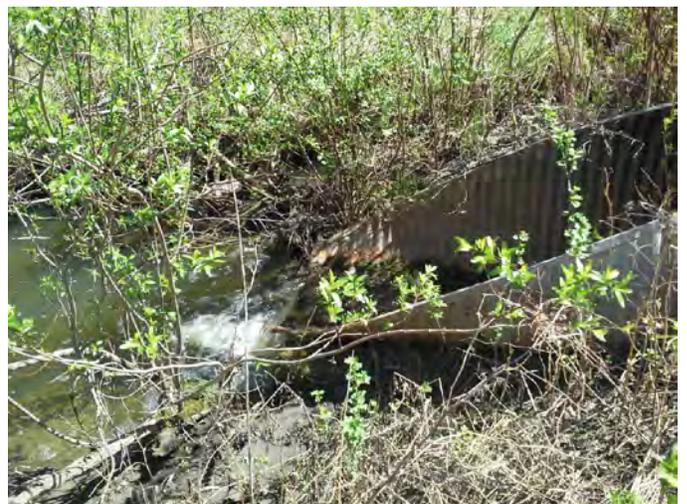
Comments: Unidentified minnows were noted downstream of culvert 2. There is an outlet gap of 0.4 meters at these culvert. These minnows could not utilize this culvert for habitat connectivity.

Photo No.: Photos-20180515-203052.jpg
Description: Culvert 2 - Outlet

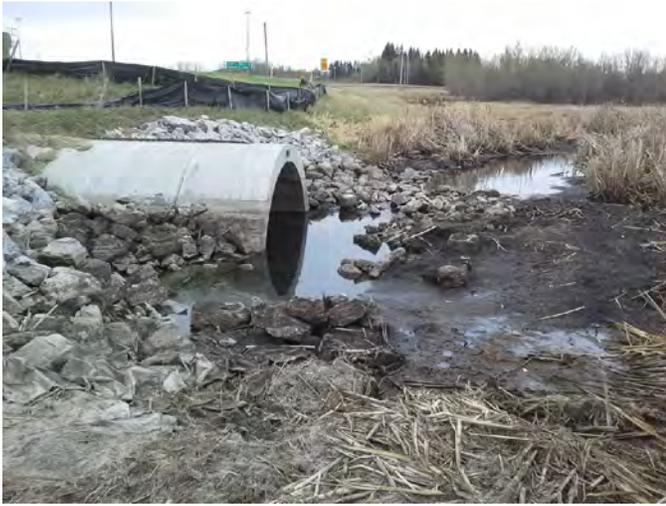
Photo No.: Photos-20180509-213309.jpg
Description: Inlet / Erosion

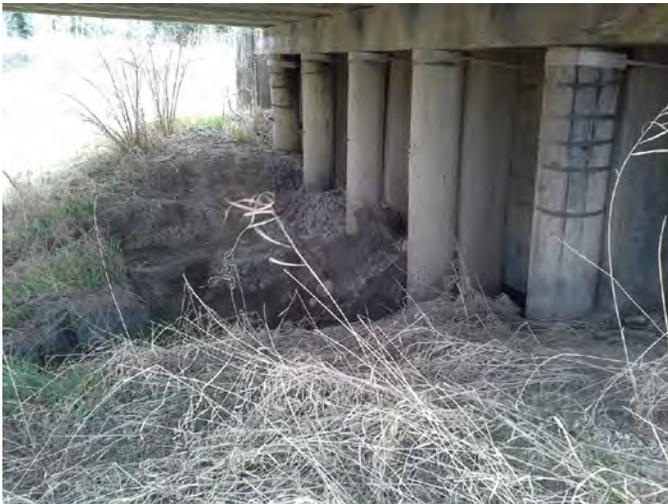
Comments: Slumping and fill slope erosion is exposing abutment walls

Photo No.: Photos-20180509-190525.jpg
Description: Slumping

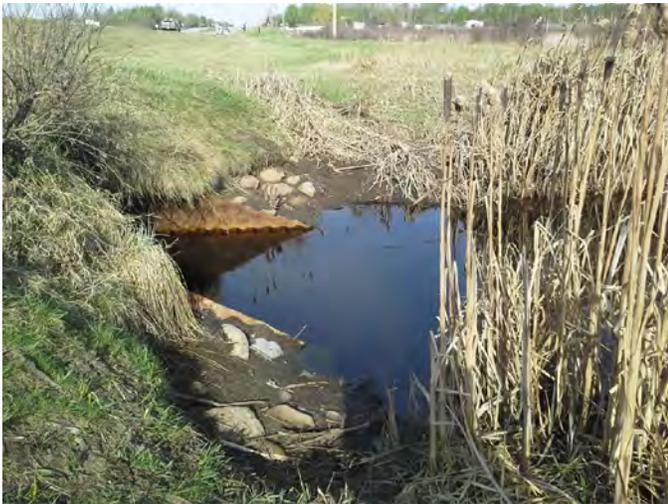
Photo No.: Photos-20180514-152308.jpg
Description: Erosion

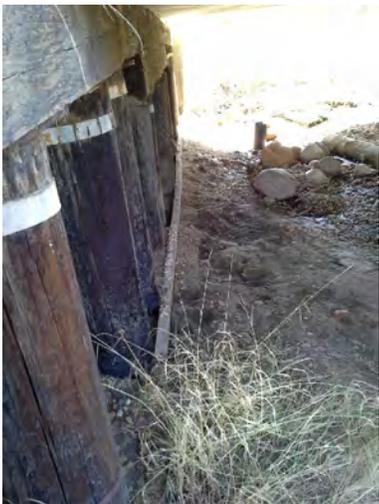
Photo No.: Photos-20180515-163027.jpg
Description: Lumber amour

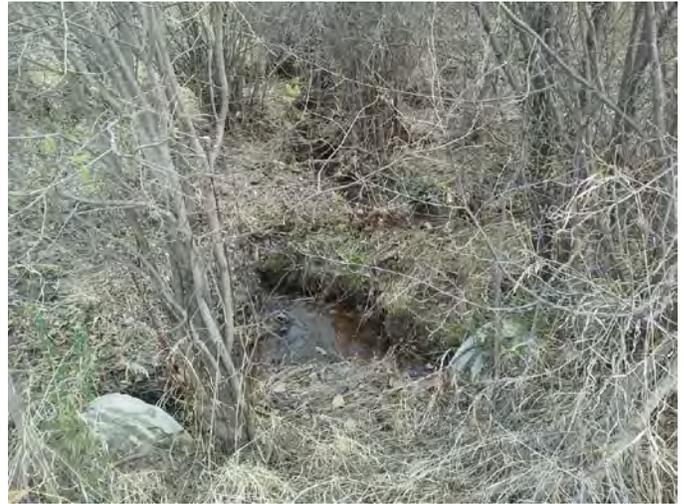
Comments: Inlets are about 30 meters apart but the outlets are within a meter of each other. Erosion is caused by slumping around outlets. Inlet gap noted at the east inlet. There is some blockage on the west inlet with large rocks. Outlet east has an accumulation of organic debris causing some blockage.

Photo No.: Photos-20180509-163349.jpg
Description: Outlets

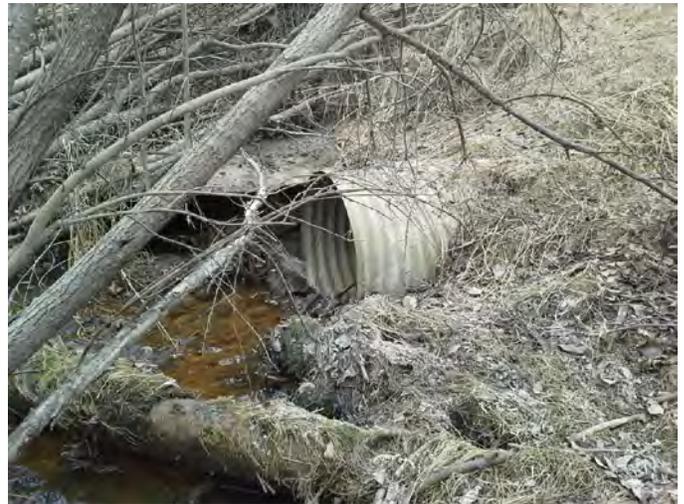
Photo No.: Photos-20180509-163731.jpg
Description: Upstream west

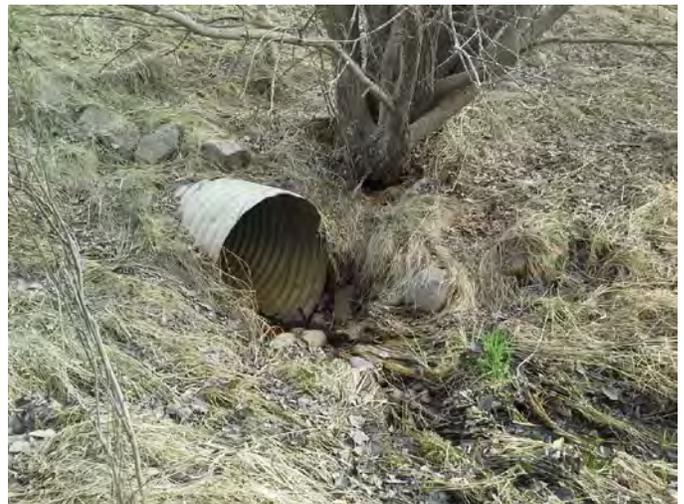
Photo No.: Photos-20180509-164137.jpg
Description: Upstream east

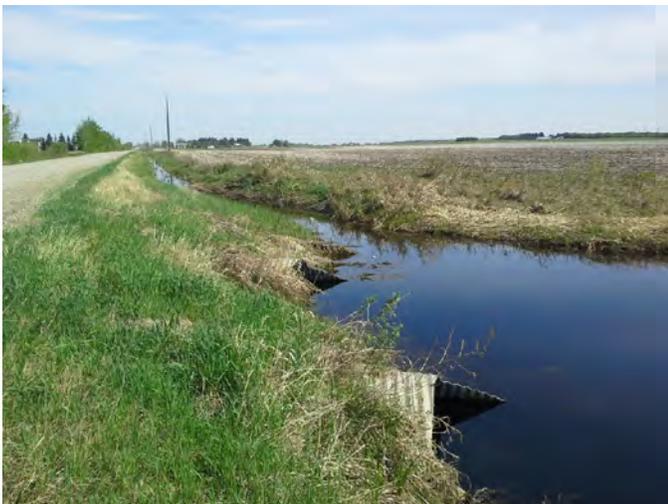
Photo No.: Photos-20180518-164958.jpg
Description: Ditch gully flows into Downstream

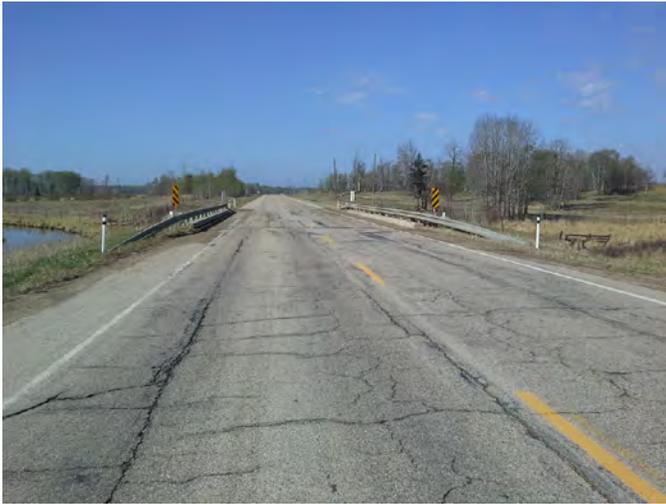
Fish Passage Assessment: No Concerns
Emergency Repair Required?: No
Overall Risk: Medium
Comments: Steep fill slope gradient is resulting in erosion. Small hole noted in bridge deck.

Photo No.: Photos-20180511-163052.jpg
Description: Deck
