Crossing ID: WC_0854

NSWA Sturgeon River Watercourse Assessment

Inspection Date: May 15, 2018

Watercourse Name: Atim Creek

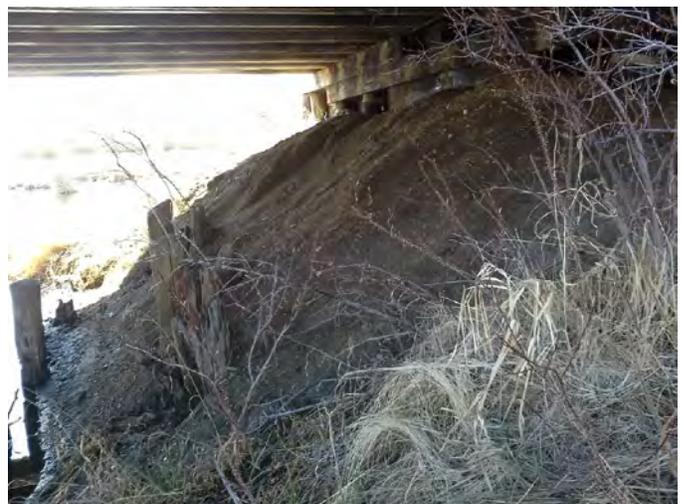
Fish Passage Assessment: No Concerns
Emergency Repair Required?: No
Overall Risk: Medium
Comments: Steep fill slope gradient is resulting in erosion. Small hole noted in bridge deck.

Photo No.: Photos-20180511-163730.jpg
Description: Erosion

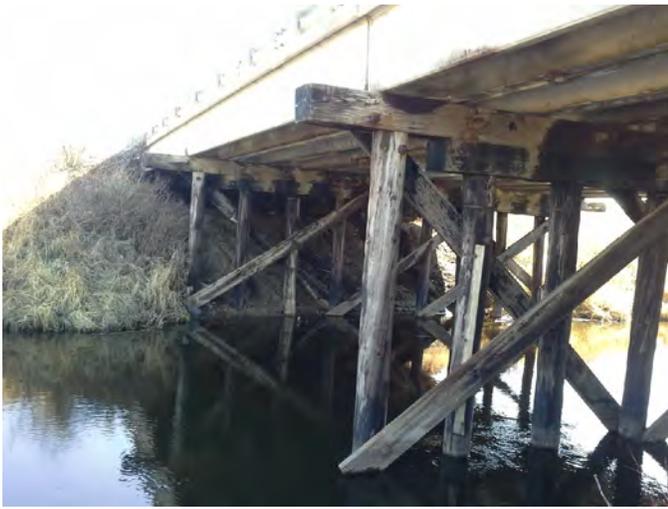
Photo No.: Photos-20180511-163750.jpg
Description: Erosion
